# 11-4403-cv

## United States Court of Appeals *for the* Second Circuit

### JOINT APPENDIX Volume 12 of 16 (Pages JA-3067 to JA-3320)

3. In 2007, I was retained by counsel for Plaintiffs in this case to provide expert analysis with respect to the cause of the global collapse of World Trade Center 7 on September 11, 2001.

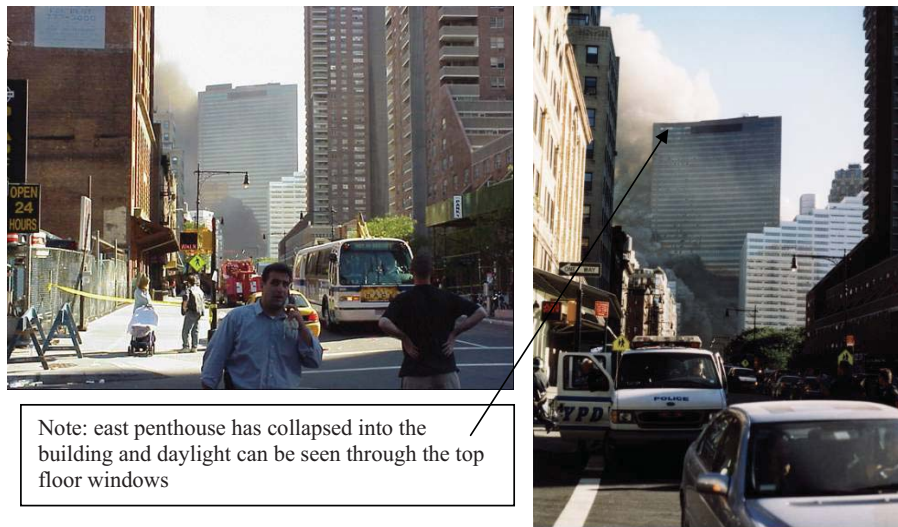
Photographic evidence (Figure 1) shows that the east roof penthouse collapsed first into the building. Figure 2 shows the location of the east penthouse highlighting that failure of column 79, or possibly column 80, occurred allowing the penthouse to sink into the building. Overall progressive collapse occurred following the collapse of the east penthouse.

Figure 1 WTC7 before collapse (left) and during collapse (right)

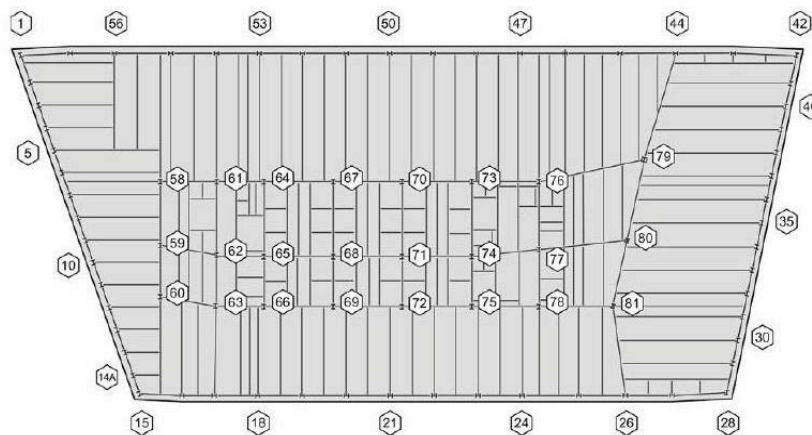
1. The large span of girder 79-44 (45ft).
2. Column 79 supporting the largest tributary area of 1891 ft<sup>2</sup>.
3. 52ft secondary beams framing into the girder on one side only.
4. Girder 79-44 supported on seating cleats, with top cleats, and four 7/8 in bolts at each end.

Figure 3 Typical structural layout for WTC7

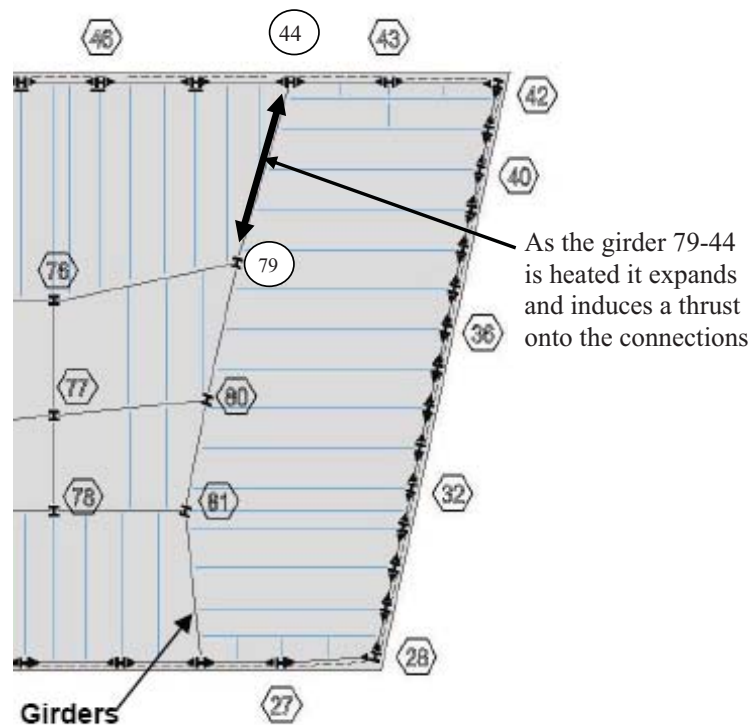
The initial failure, leading to overall collapse, occurred in the connection between column 79 and girder 79-44. During the initial stages of the fire the girder expanded longitudinally as it increased in temperature. This expansion placed a thrust onto the seated connections at columns 79 and 44 as shown in Figure 11.

Figure 11 Expansion of girder 79-44 in the early stages of the fire

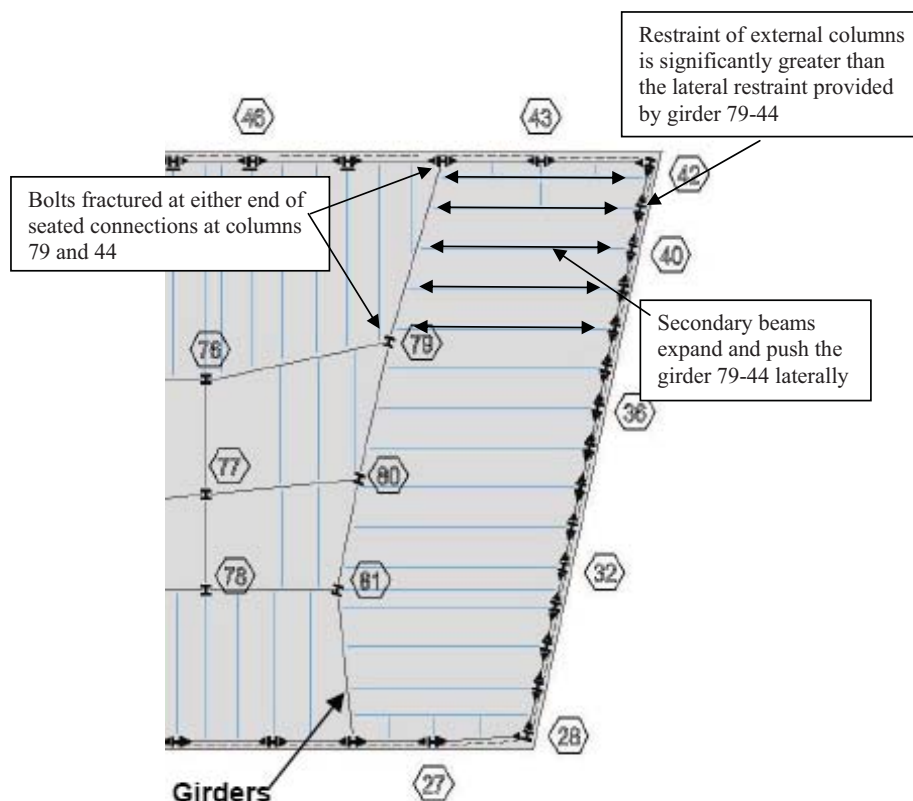
As well as thermal expansion of the secondary beams causing lateral movement of the girder 79-44, the vertical deflection of the secondary beams, as they lose strength and stiffness with increase in temperature, will cause the girder 79-44 to twist.

Figure 13 Showing thermal expansion of secondary beams

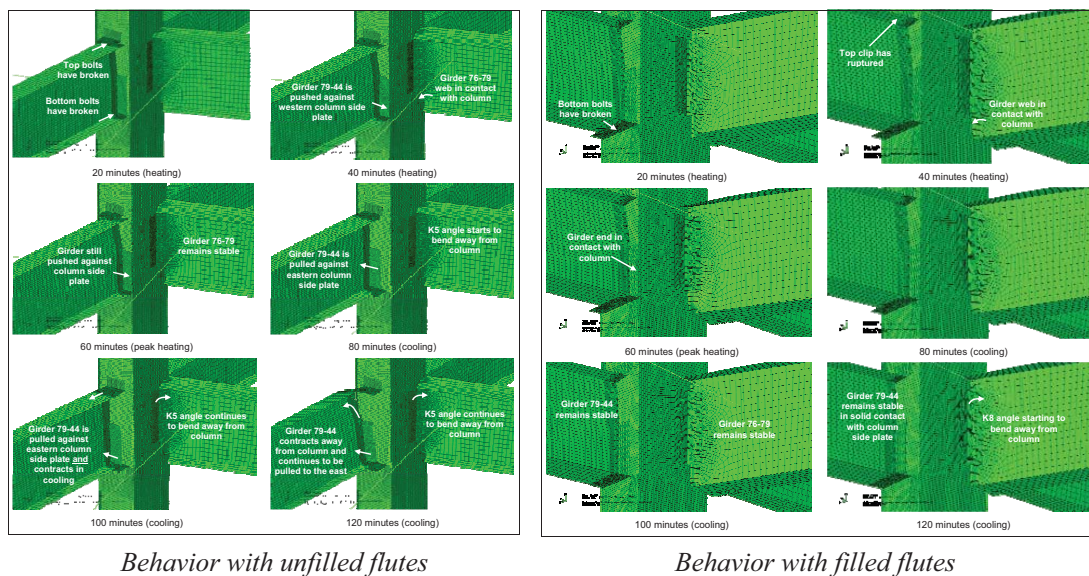
The behavior of the girder 79-44, at the connection with column 79, is shown in Figure 28 for case 1 (unfilled flutes) and case 2 (filled flutes). The important observation is the significant difference in structural behavior due to the filling of the flutes.

Figure 28 Behavior of girder 79-44 at column 79 for unfilled flutes (left-hand figure) and filled flutes (right-hand figure)

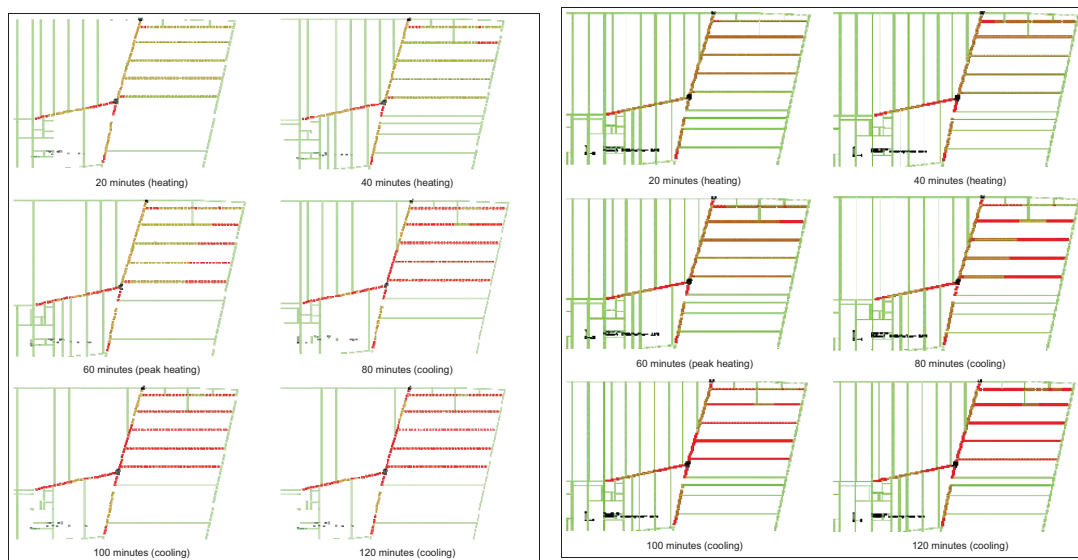
The failure of the shear studs for both case 1 and case 2 is summarized in Figure 29, where the red dots denote failure of the studs. It can be seen that most studs fail during the cooling stage of the fire, with greater stud failure occurring in case 1, where the flutes were unfilled.

Case 1: Flutes unfilled 700°C fire

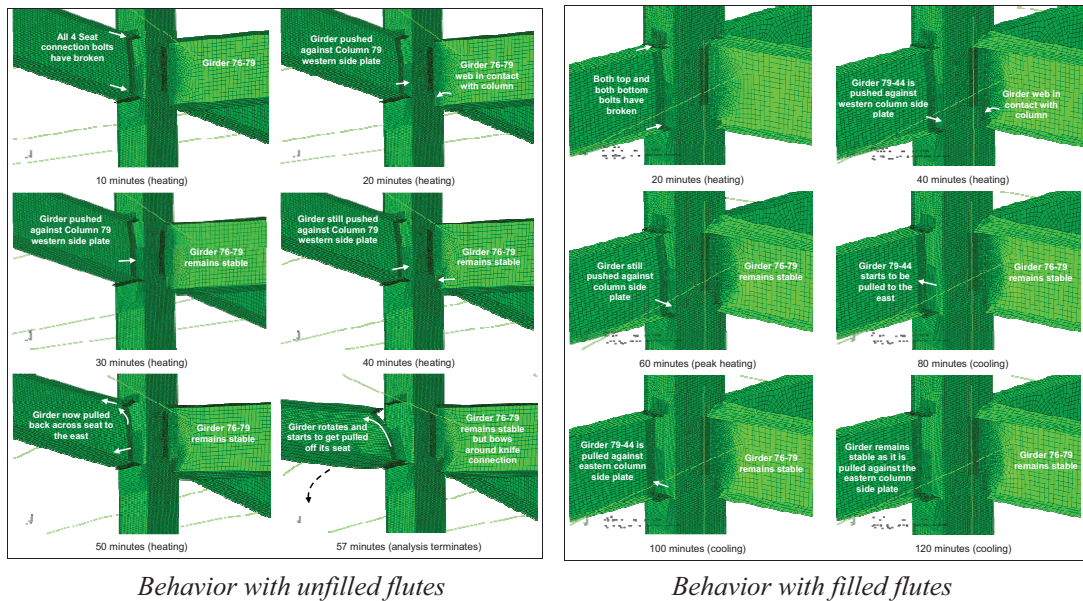
The behavior of the girder 79-44, at the connection with column 79, is shown in Figure 31 for case 3 (unfilled flutes) and case 4 (filled flutes).

Behavior with unfilled flutes

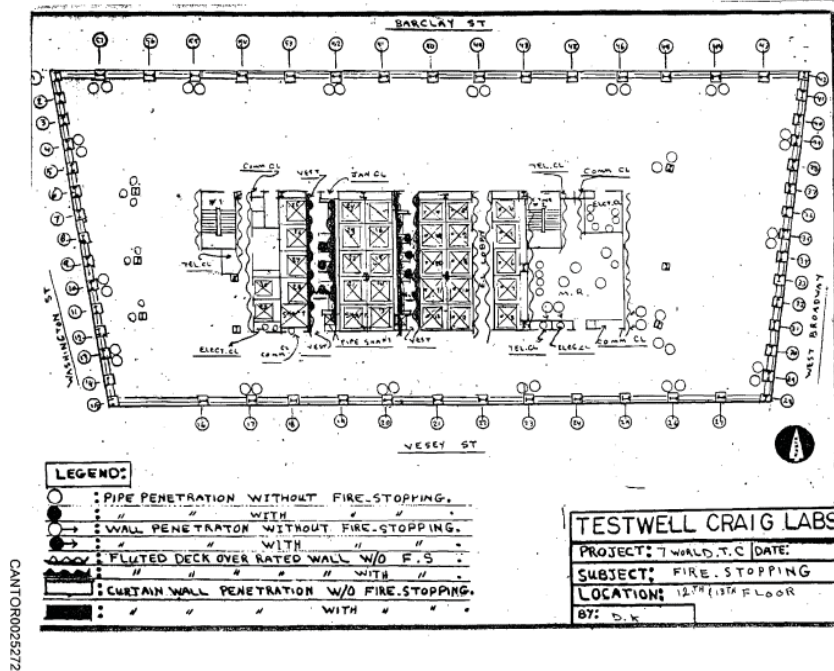
Details from Testwell Craig Laboratories reports showing unfilled flutes over fire rated walls.

Figure B1 Sketch showing unfilled flutes above fire walls which had firestopping missing (12<sup>th</sup> and 13<sup>th</sup> floors).

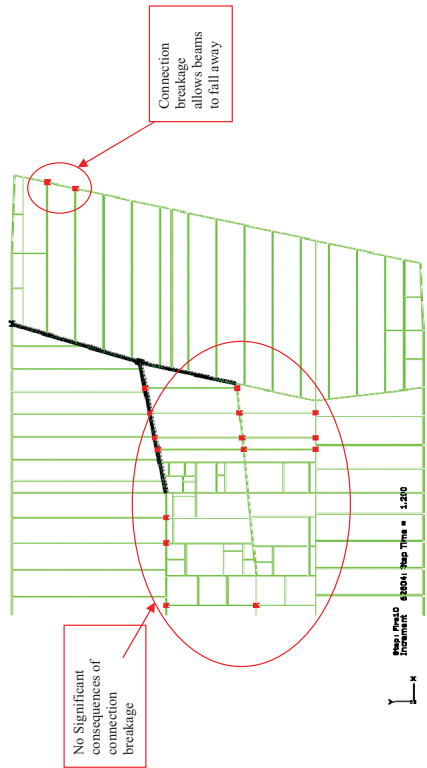
The failure of the 2 connectors in the NE corner of the building after 80 minutes of analysis time is related to the tensile forces induced during cooling. This breakage leads to the falling away of the secondary beams as they have also lost composite connection to the slab above. This response leads to larger residual deflection in the north-east bay compared to the rest of the structure.

Figure 81: 800°C Filled Flutes Case 4 - Breakage of Simplified Connections

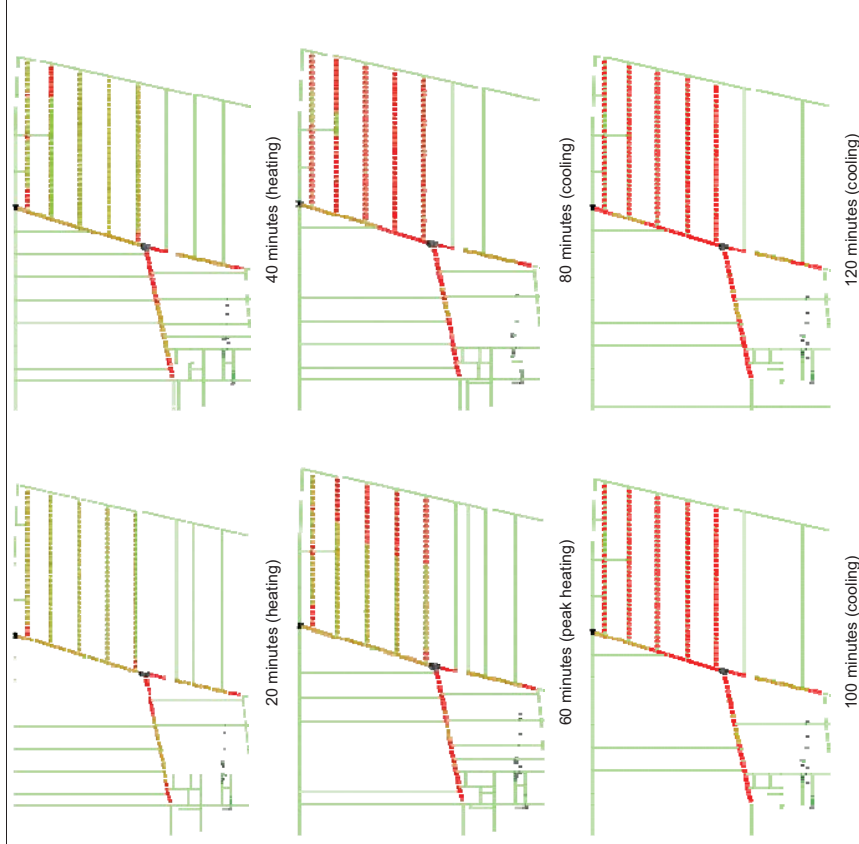
Figure 99: Shear stud failures within the north-east bay at 20 minute intervals throughout the duration of the analysis. Brown markers indicate unbroken shear studs while red markers indicate broken shear studs. During the heating phase of the fire, shear stud breakages are observed at either end of Girders 76-79 and 79-80 and also on the eastern third of beams in the north-east bay. During the initial cooling phase, a significant number of shear studs break due to differential cooling between the concrete slab and the steel beams. These include almost all shear studs on the secondary beams and the majority on each of the three girders into Column 79.

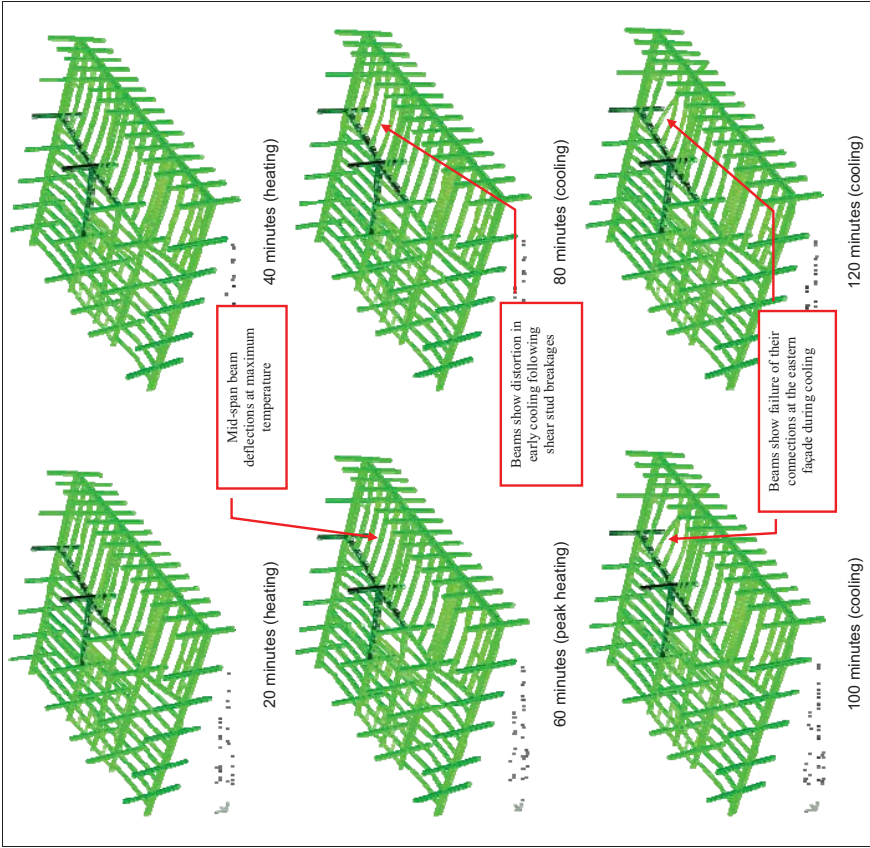
Figure 132: Deformed structure images of the structural frame of Floor 13 at 20 minute intervals throughout the analysis. Two secondary beams in the north-east bay fail at their connections to the eastern façade columns as the beams contract due to cooling and create large tension forces. Girder 79-44 is pulled across its seat plate to the east during cooling by the secondary beams but remains stable on its seating plates at both Column 44 and Column 79. No initiating collapse mechanism is observed.

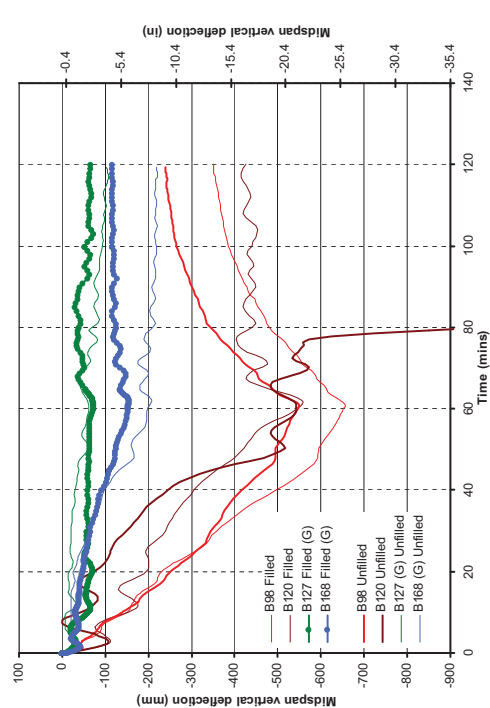
Figure 45: Comparison of mid-span vertical deflections of selected beams and girders for flutes filled and unfilled condition under 700°C heating (Case 1 and Case 2). B120 unfilled is a secondary beam in the NE bay that undergoes connection failure and falls away from the underside of the slab.

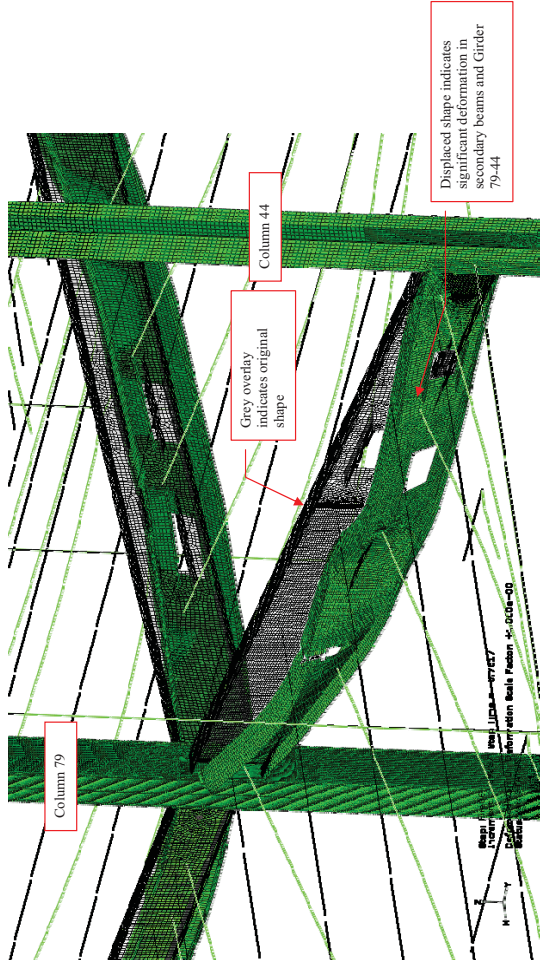
Figure 58: 800°C Unfilled Flutes Case 3 - Failure Mechanism of Girder 79-44 at Analysis Termination
