Analysis of Structural Response of WTC 7 to Fire and Sequential Failures Leading to Collapse

Therese McAllister, Ph.D., P.E., M.ASCE[1]; Robert MacNeill[2]; Omer Erbay, Ph.D., P.E., M.ASCE[3];
Andrew Sarawit, Ph.D., P.E., M.ASCE[4]; Mehdi Zarghamee, Ph.D., P.E., F.ASCE[5];
Steven Kirkpatrick, Ph.D.[6]; and John Gross, Ph.D., P.E., F.ASCE[7]

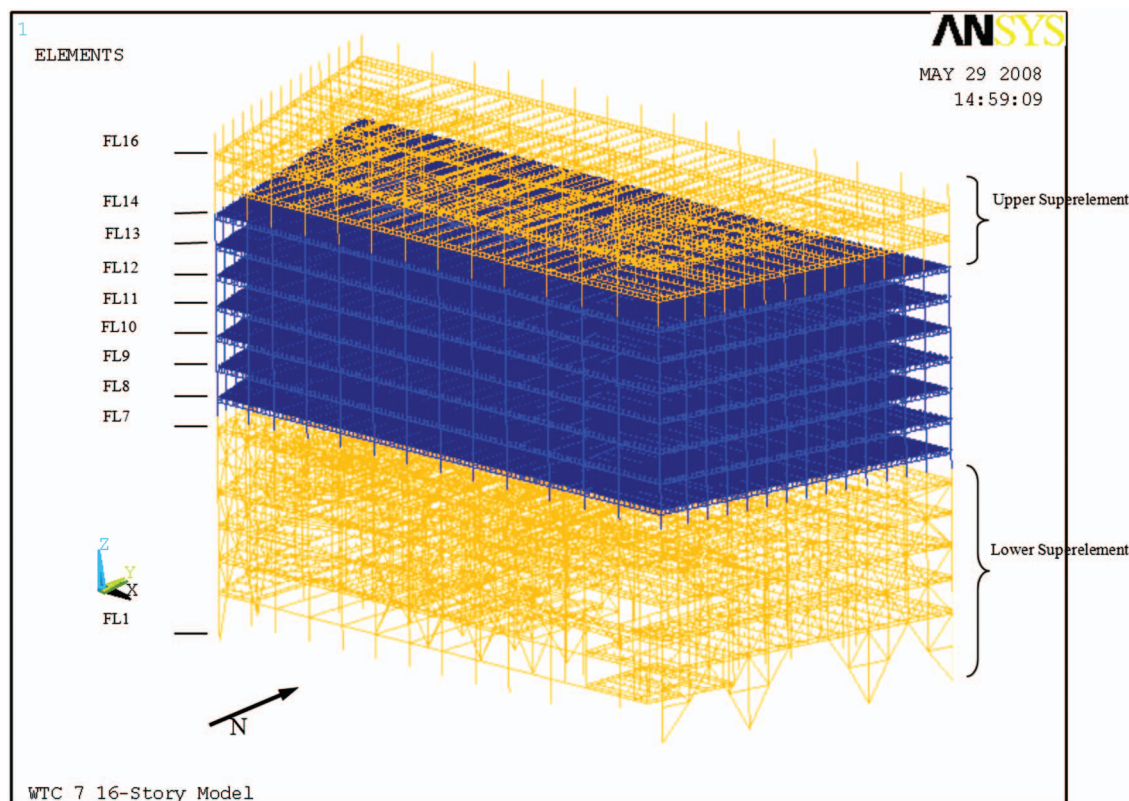
Fig. 3. (Color) 16-story pseudostatic model representing lower 16 floors of the WTC 7 building; the nonlinear part of the model subjected to thermal loading is shown in blue (McAllister et al. 2008)

The 16-story pseudostatic finite-element model (see Fig. 3) had the following features:
- Floors from ground level to Floor 16, because sustained fires were observed on Floors 7 to 9 and Floors 11 to 13 (McAllister et al. 2008).
- Representations of columns, beams, girders, composite floor slab, and connections.
- Geometric and material nonlinearities, including temperature-dependent material properties, and thermal expansion.
- Evolving temperature states, which included heating and cooling phases, input as a temperature time history for each node, distinct from other nodes, at 30-min intervals with linear interpolation between temperature states.
- Connection models that simulated failure of connection components.
- Failure criteria for connections, shear studs within a composite floor system, buckling instability of beams and girders, and concrete floor slabs.

Material and geometric nonlinearities were assigned to the structure between Floors 8 and 14, whereas Floor 7 and below and Floors 15 and 16 were modeled linearly with substructuring (superelements in ANSYS) to reduce the size of the model. The gravity loads above Floor 16 were applied to the Floor 16 columns. Substructuring and exclusion of the building above Floor 16 allowed the analysis to remain tractable while including details of the framing and floor connections at the lower floors where fires were observed.

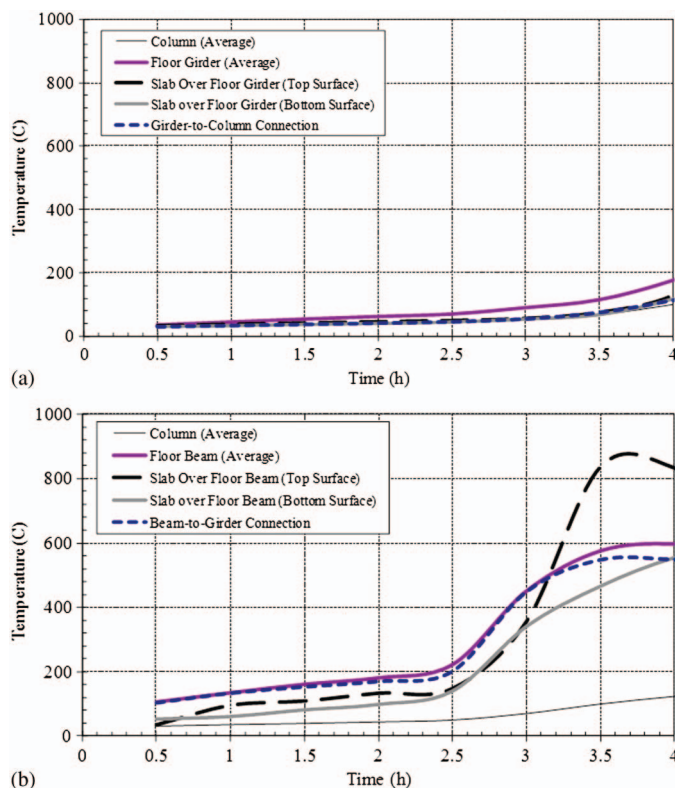
Fig. 4. (Color) Temperature time history of selected floor framing and slab at Floor 13

The computed temperatures in the steel floor framing of Floor 13 at 3.0 h, 3.5 h, and 4.0 h, shown in Figs. 5(a)–5(c), are largely because of heating from fire on the floor below. The corresponding computed failures of floor beams and girders of Floor 13 are shown in Fig. 5(d)–5(f) (for other floors, see McAllister et al. 2008). In the east floor area, as a floor beam thermally expanded, it laterally displaced the interior girder but not the exterior framing with moment connections, which was much stiffer. Shear studs connecting the slab to the floor beam primarily failed by differential thermal expansion between the steel beams and the concrete slab. Floor-beam buckling was attributed to the combined effects of (1) loss of lateral restraint when shear studs failed, (2) increased axial loads attributed to restraint of thermal expansion, and (3) gravity loads from the floor slab. Girder walk-off occurred when the beams (that framed into girders from one side) thermally expanded and pushed the girder laterally, sheared the bolts at the seated connection, and then continued to push the girder until it walked off the bearing seat. Although cooling occurred for many structural members in other parts of the structure, the beams, girders, and connections that contributed to collapse initiation had not begun cooling between 3.0 h and 4.0 h of heating (see Fig. 4).

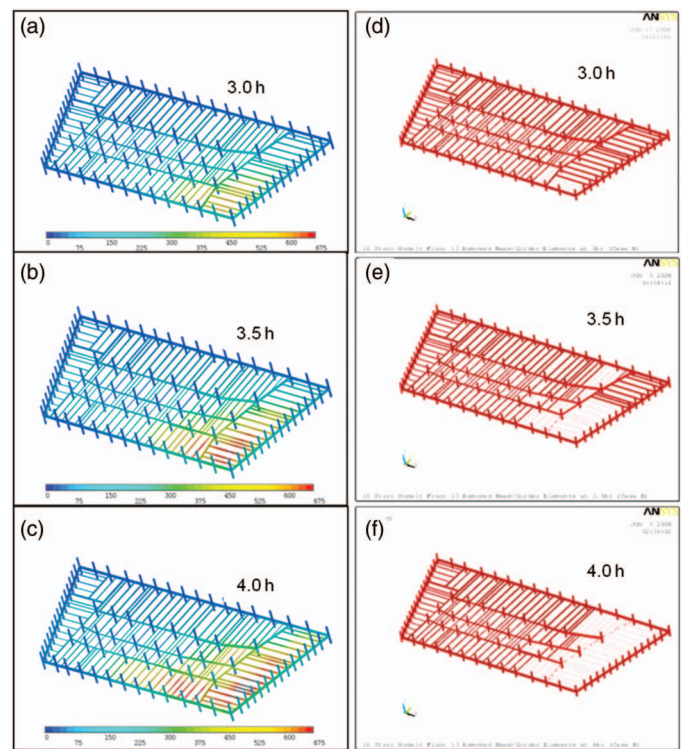
Fig. 5. (Color) Floor 13 framing temperatures at (a) 3.0 h; (b) 3.5 h; (c) 4.0 h (temperature scale range: 0 to 675 °C; temperatures > 675°C are gray); ANSYS Floor 13 beam and girder failures (by buckling or end connection damage) at (d) 3.0 h; (e) 3.5 h; (f) 4.0 h (McAllister et al. 2008)

Thermal expansion of beams and girders caused connection failures in the form of (1) bolt shear, (2) failure of welds, and (3) walk-off of the seated connections after bolts had sheared off. Failure of bolts or welds in shear connections (single plate or double angle) resulted in loss of horizontal and vertical support to beam and girders. In seated connections, bolt failure caused loss of horizontal support but not vertical support. Loss of vertical support occurred when the beam or girder walked off the bearing seat. Other factors that contributed to this failure were an absence of shear studs on the girders, which would have provided lateral restraint, and the one-sided framing of the east girders by the floor

beams, which allowed the floor beams to push laterally on the girder when thermally expanding.

The pseudostatic analyses showed that the floor framing and slabs at Floors 8 to 14 were weakened by fire after 4.0 h of heating, and Columns 79, 80, and 81 had lost lateral support at several floors. The fire-induced failures of the floor framing resulted in increased unsupported column lengths for Columns 79, 80, and 81. At this point in time, Column 79 was laterally unsupported at three floors in the east-west and north-south directions, Column 80 was laterally unsupported at one floor in the east-west and north-south directions, and Column 81 was laterally unsupported at one floor in the north-south direction. The pseudostatic analysis simulated structural response to fire but did not include the dynamic effects of component failures. To calculate the dynamic structural response and determine whether subsequent failures resulted in total collapse, a separate dynamic analysis was performed.

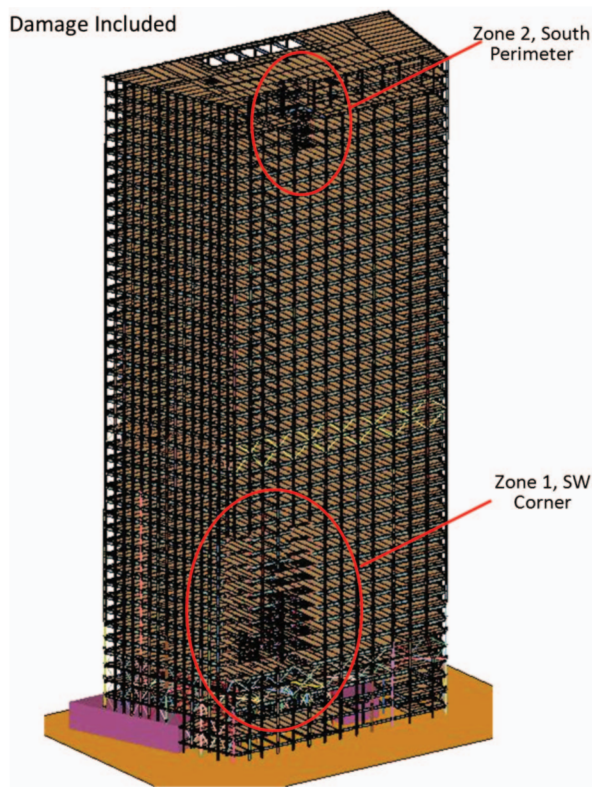
Fig. 6. (Color) 47-story model of the WTC 7 building with debris impact damage, with damage at southwest corner (McAllister et al. 2008)

The 47-story dynamic model, shown in Fig. 6, represented the steel framing, slabs, connections, and composite floor construction with shell elements. The dynamic model included the following as its initial condition: structural damage attributed to debris impact from the collapse of WTC; structural damage from pseudostatic analysis; and mechanical properties for steel components for the temperature at the time collapse initiation. The model simulated component

The extent of exterior structural damage to WTC 7 from debris impact during the collapse of WTC 1 (estimated from photos and videos) occurred primarily between Floors 7 and 17 in the southwest quadrant of the building. Two debris-impact damage cases were used in the dynamic analyses to determine their contribution to the sequence of structural failures: (1) the observed exterior structural damage and estimated interior structural damage to floors, and (2) no structural damage from debris impact. The effect

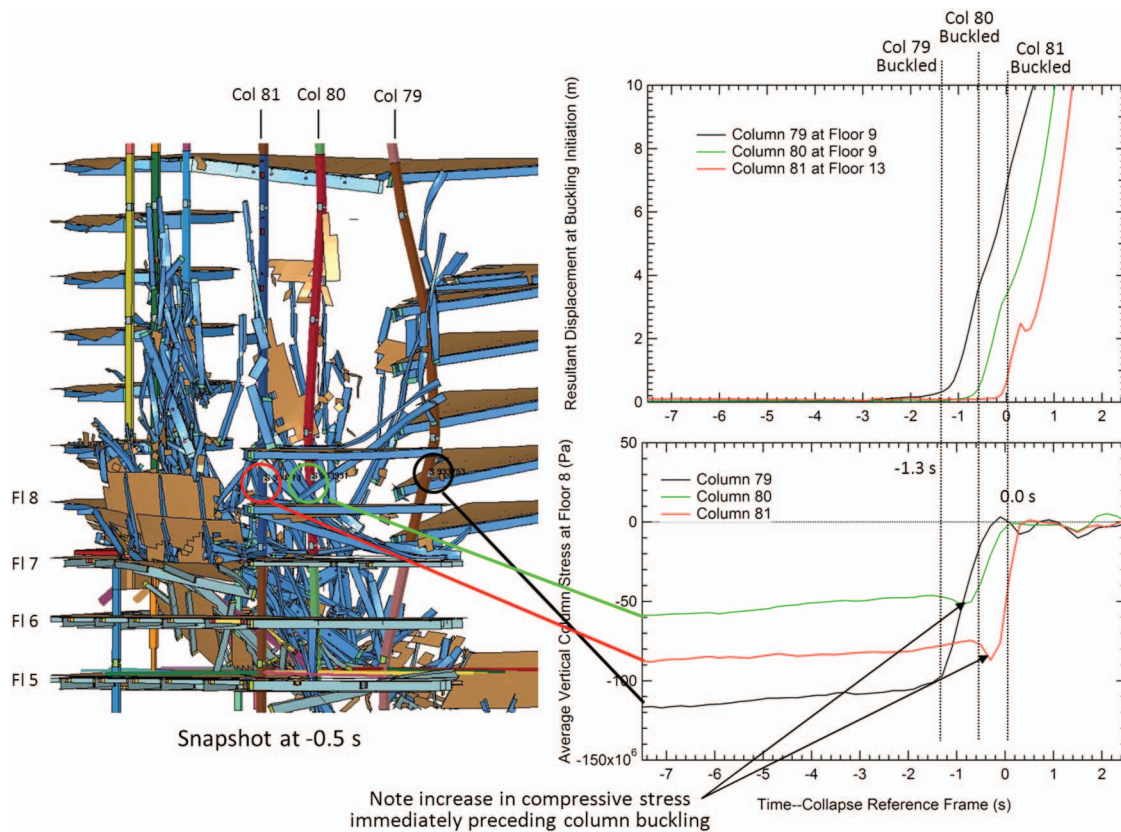
Fig. 7. (Color) Column 79 and 81 stress and displacements (McAllister et al. 2008); note: the collapse reference time of zero (0.0 s) is the point in time when the east penthouse structure on the roof of WTC 7 began to move downward

The dynamic analysis computed a sequence of failure events that simulated the structural response to the fire-induced damage from the pseudostatic analysis. The floor framing was thermally weakened at Floors 8 to 14, with the most substantial fire-induced damage occurring on the east side of Floors 12, 13, and 14. The fires on Floors 11, 12, and 13 (which heated Floors 12, 13, and 14) had higher combustible loads than Floors 7, 8, and 9. Floor sections on Floors 13 and 14 collapsed to the floors below. The floor systems progressively failed down to Floor 5, where debris accumulated, and left Column 79 laterally unsupported in the east-west and south directions between Floors 5 and 14. Laterally unsupported Column 79 buckled and failed between these floors. The buckling failure of Column 79 led to a series of floor failures up to the roof. A downward kink in the east penthouse roof framing near Column 79 was observed in videos. A cutaway view of the structural condition surrounding Column 79 as it buckled to the east is shown in Fig. 7, along with resultant lateral displacements and column axial stress histories for Columns 79 to 81. The plots show that Column 79 began to buckle 1.3 s before the east penthouse began to descend

into the building. The floor failures also led to Columns 80 and 81 buckling and floor failures across the east side of WTC 7.

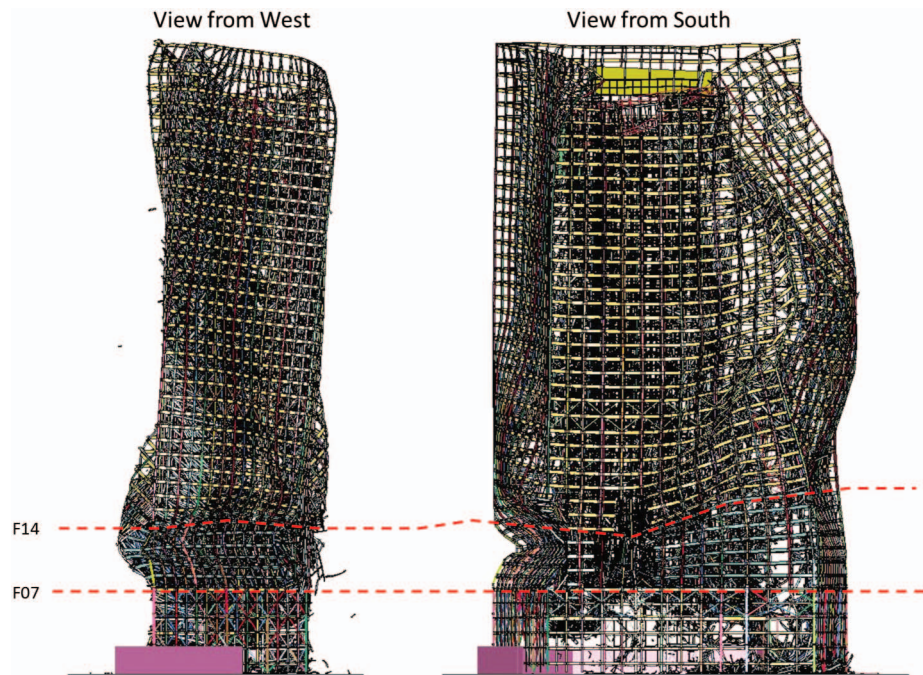
Fig. 8. (Color) Exterior column buckling after initiation of global collapse with debris impact and fire-induced damage (slabs removed from view) (McAllister et al. 2008)

The failures progressed westward as the debris fell and impacted adjacent intact columns and floors, until all interior columns had buckled between Floors 9 and 14. The exterior columns were left laterally unsupported in the east, south, and north faces (the west face floors remained intact above Floor 9 because no fires were observed above this floor). Exterior Column 14, adjacent to the debris impact zone, buckled first. When all exterior columns had buckled within approximately 2 s between Floors 7 and 14, as shown in Fig. 8, the building above the buckled-column region moved downward, resulting in the global collapse of WTC 7.
