SKILLING, HELLE, CHRISTIANSEN, ROBERTSON — Structural & Civil Engineers

PROJECT: THE WORLD TRADE CENTER | TITLE: K1 EL. 310 REPAIR DETAIL FOR EXISTING STEEL | DATE: 6-12-72

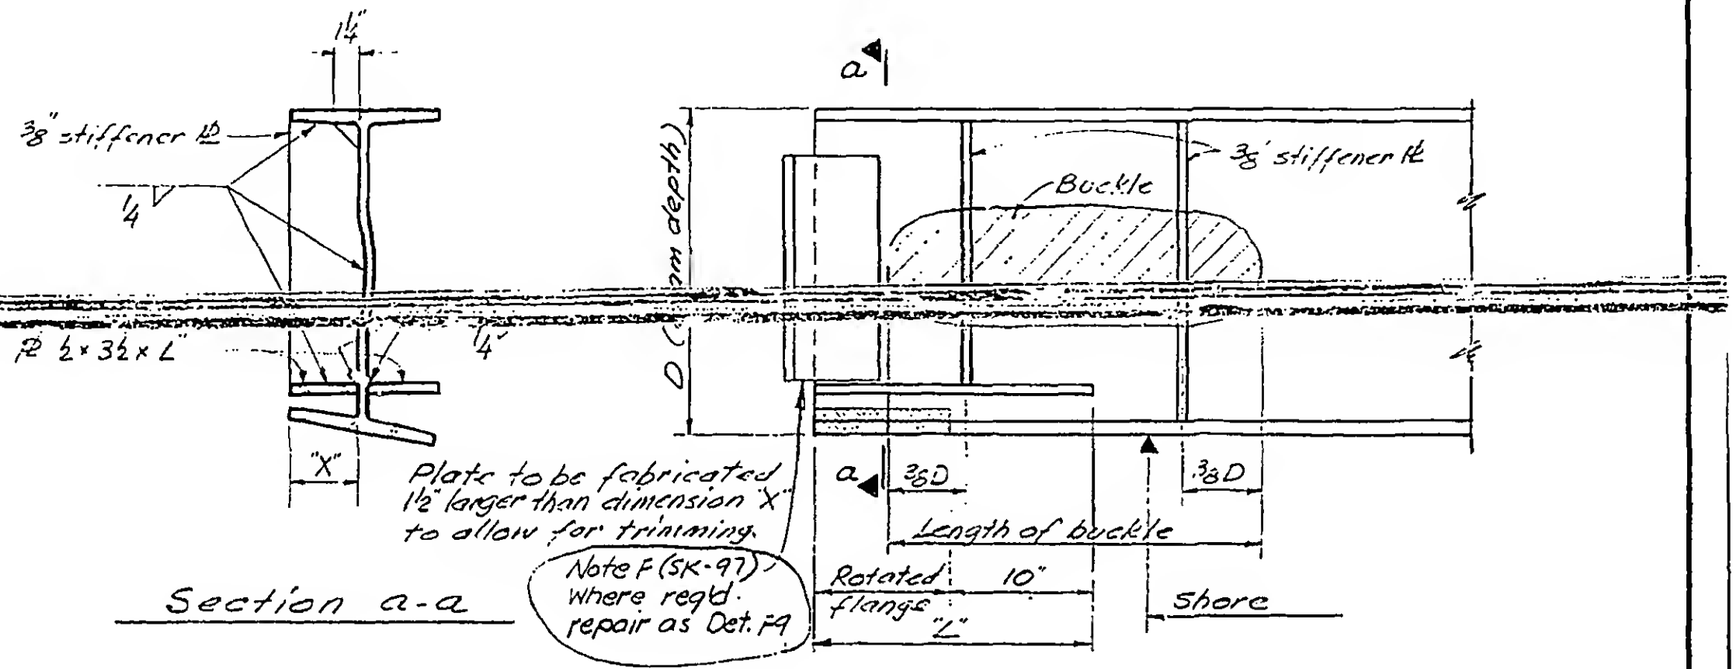
Detail F5

Buckled acc. failed connection & rotated flange

Plate to be fabricated 1½" larger than dimension "X" to allow for trimming.

Note F (SK-97) Where reqd. repair as Det. F4

⅜" stiffener plates to be placed as follows:

LENGTH OF BUCKLE	NO. OF PLATES	PLACEMENT OF STIFFENERS
0.75 D	1	Center in bulge
0.75 D > 1.00 D	2	as shown above
1.00 D > 2.00 D	3	2 outside as shown above - center one centered between

1. Shore beam.
2. Remove damaged connections.
3. Replace with same type connection, but capacity to be as shown in Plan.
4. Install horizontal plates.
5. Trim vertical stiffener plates to fit and install number and location as shown in table.
6. Remove shores.
