SKILLING, HELLE, CHRISTIANSEN, ROBERTSON — Structural & Civil Engineers

PROJECT: THE WORLD TRADE CENTER | TITLE: K1 - EL. 310 REPAIR DETAIL FOR EXISTING STEEL | DATE: 6-12-72

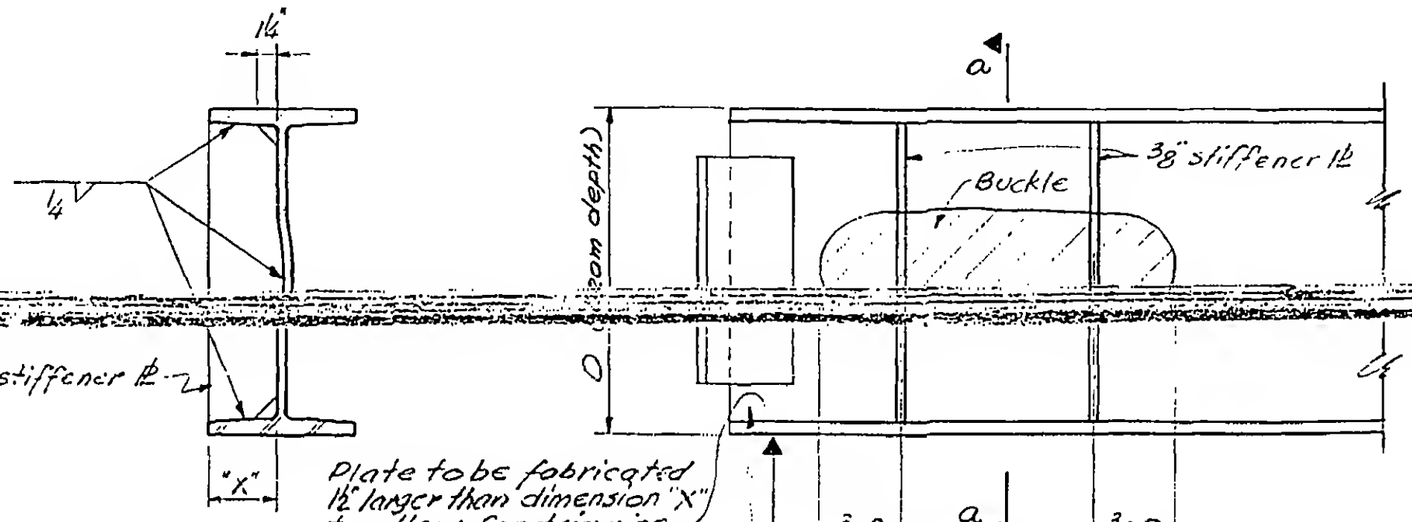
Detail F7

Buckled web & failed connection

3/8 stiffener plates to be placed as follows:

LENGTH OF BUCKLE	No. of PLATES	PLACEMENT OF STIFFENERS
0.75 D	1	Center in bulge
0.75 D > 1.00 D	2	as shown above
1.00 D > 2.00 D	3	2 outside as shown above - center one centered between

1. Shore beam
2. Remove damaged connection. (Bolts, angles & welds)
3. Replace with same type connection, but capacity to be as shown in Plan
4. Trim vertical stiffener plates to fit and install number and location as shown in table
5. Remove shores
