# 11-4403-cv

## United States Court of Appeals *for the* Second Circuit

### JOINT APPENDIX Volume 12 of 16 (Pages JA-3067 to JA-3320)

3. In 2007, I was retained by counsel for Plaintiffs in this case to provide expert analysis with respect to the cause of the global collapse of World Trade Center 7 on September 11, 2001.

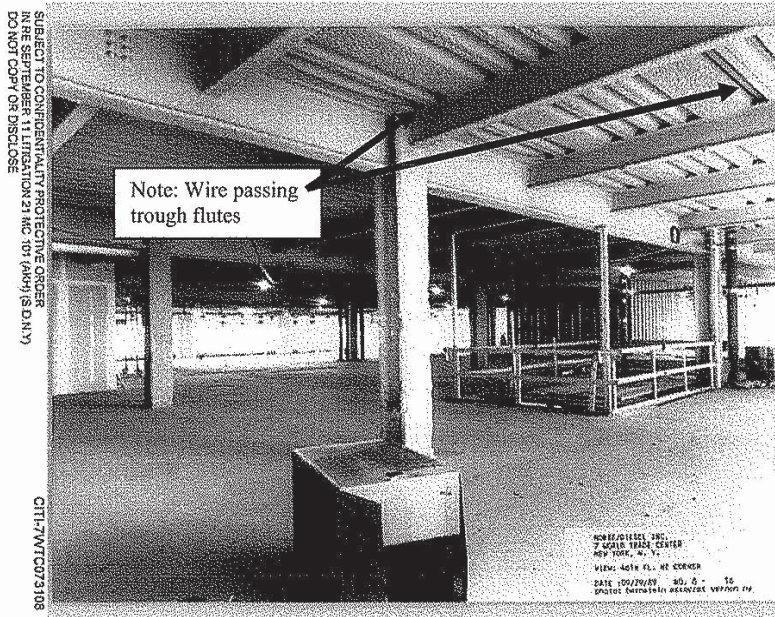
The construction of WTC7 was completed in 1987. These photographs were taken during 'fit-out' of the floors in 1989. They show that the flutes were not filled with fire protection as required. They also show in a number of cases wires being passed through the open flutes.

Figure A1: Photograph showing wire placed through flutes (46<sup>th</sup> Floor).

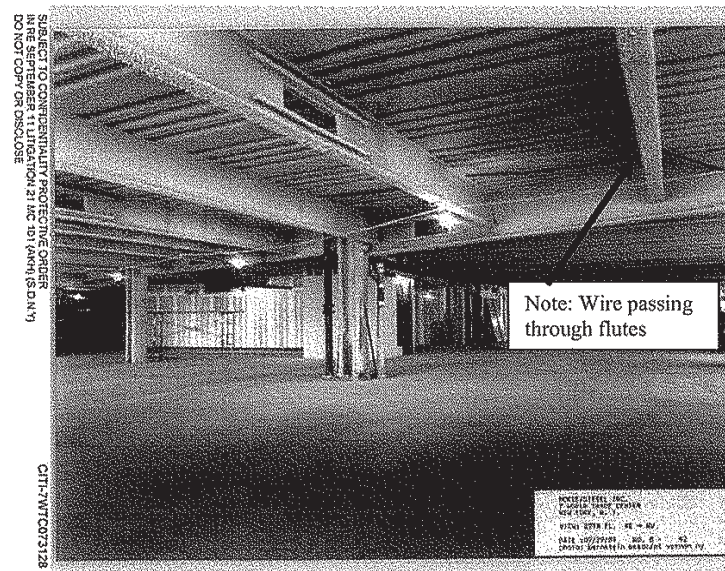
Figure A3: Photograph showing wire placed through flutes (29<sup>th</sup> Floor).

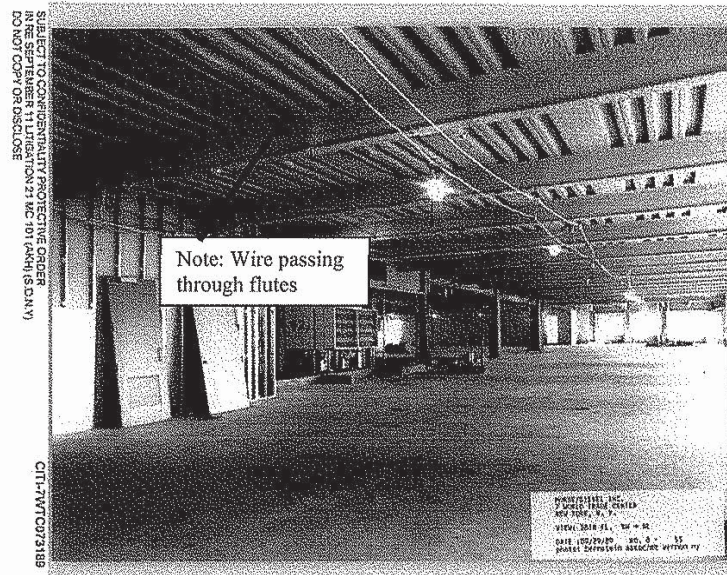
Figure A4: Photograph showing wire placed through flutes (38<sup>th</sup> Floor).

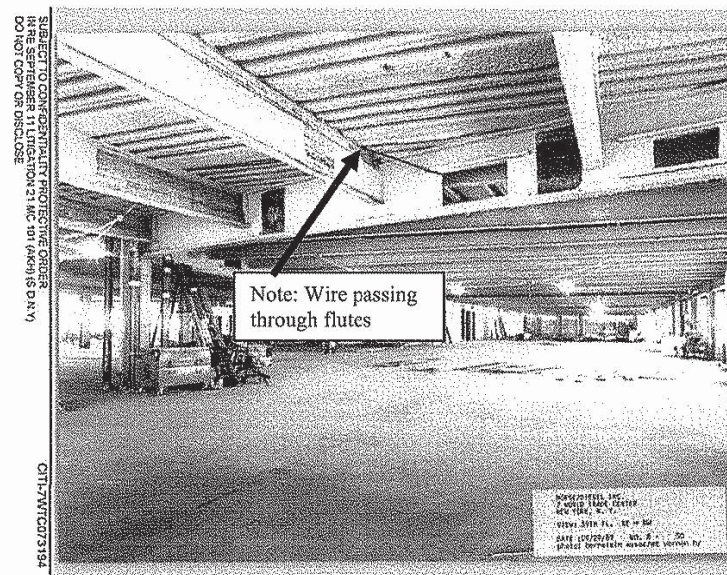
Figure A5: Photograph showing wire placed through flutes (39<sup>th</sup> Floor).

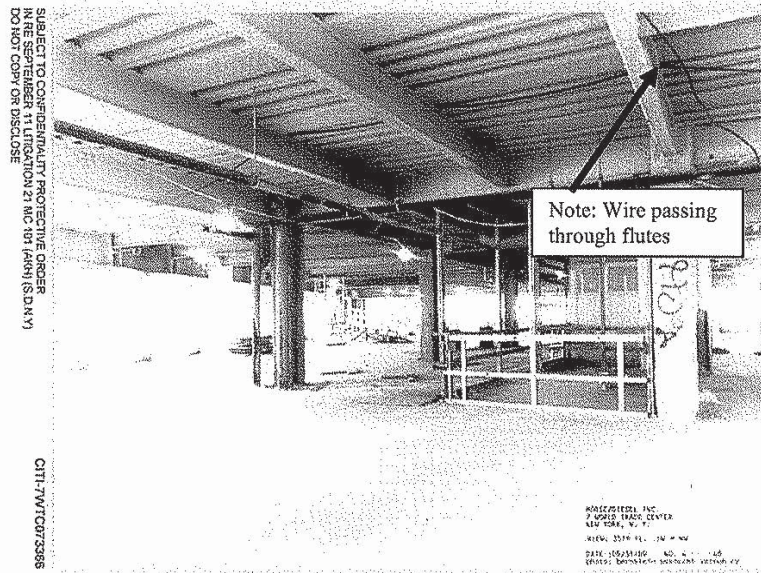
Figure A8: Photograph showing wire placed through flutes (35<sup>th</sup> Floor)

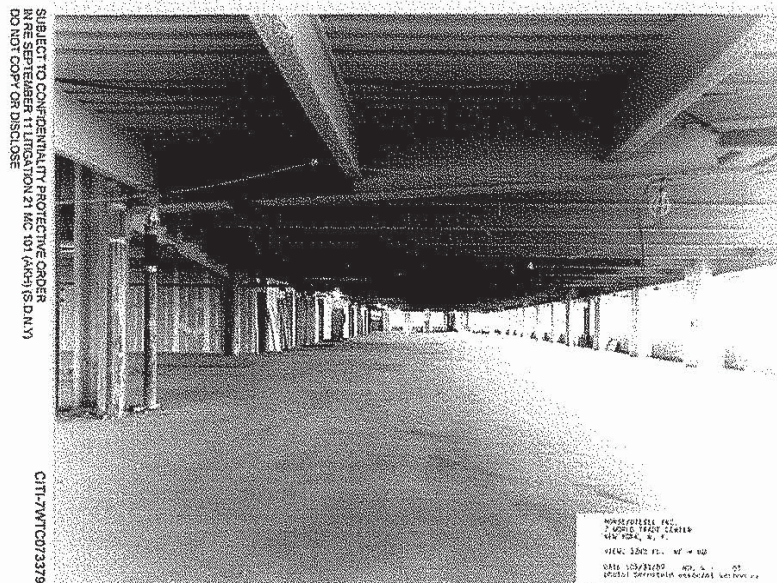
Figure A9: Photograph showing wire placed through flutes (32<sup>nd</sup> Floor)

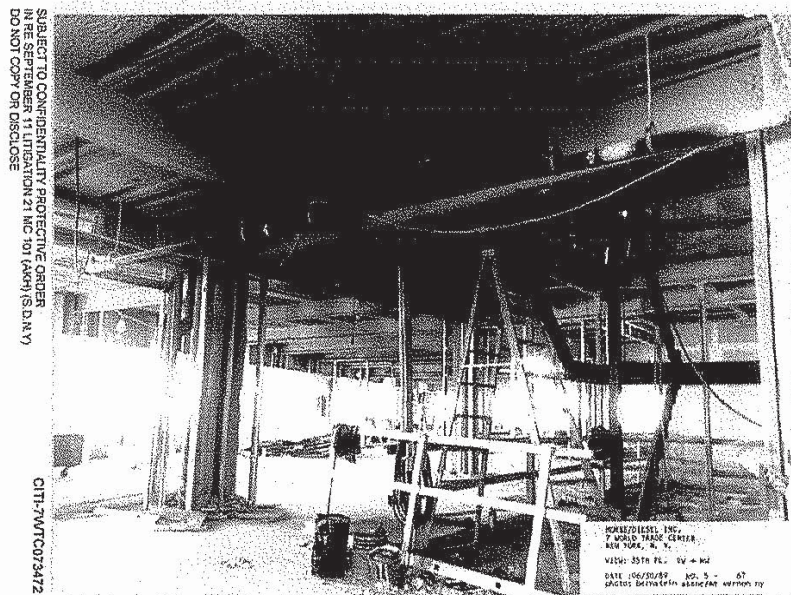
Figure A10: Photograph showing wire placed through flutes (35<sup>th</sup> Floor)

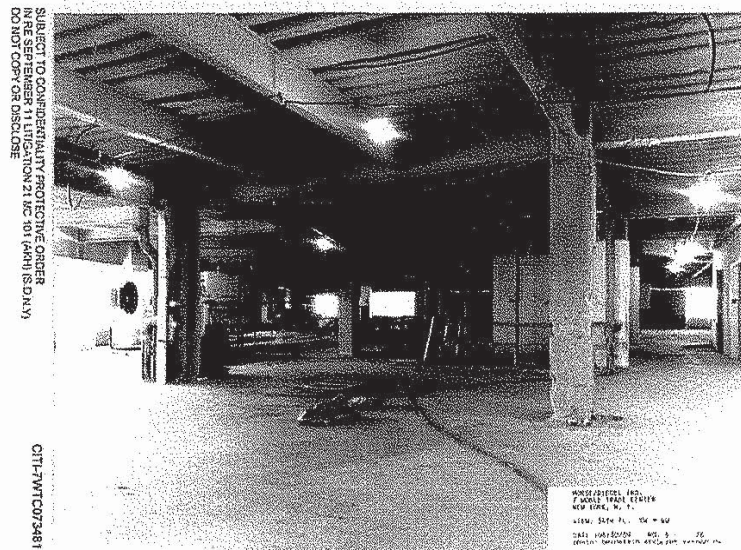
Figure A11: Photograph showing wire placed through flutes (34<sup>th</sup> Floor)

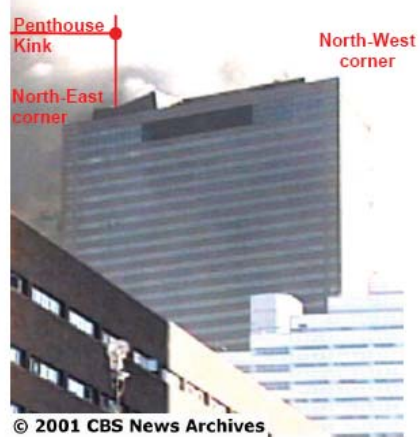
Figure 4 Collapse of the penthouse.

Closer investigation of the collapse of the penthouse also indicates that it was column 79 which failed first. Figure 4 shows a clear ‘kink’ in the north face of the penthouse, with the east and west walls being pulled inwards as it collapses into the building. This suggests that the girder 79-44 which is supporting the steel post to the penthouse on the roof at the location of the kink (Figure 4), is failing. Since the external column 44 remains stable as the penthouse sinks into the building (Figure 1) then Column 79 must have collapsed first.

Due to the lack of significant glass breakage (Figure 4), as the penthouse sinks into the building, it can be concluded that the collapse of column 79 initiated lower down in the building at the location of the office fires below Floor 13. Visual evidence shows that there were two primary ways in which the standard office floor fires moved within WTC7: clockwise and counterclockwise, as outlined in expert report by Dr Fred Mower<sup>(9)</sup>. The office fires on Floors 11, 12, and 13 were first observed on the eastern side of the building and travelled in a counterclockwise direction. Conversely,

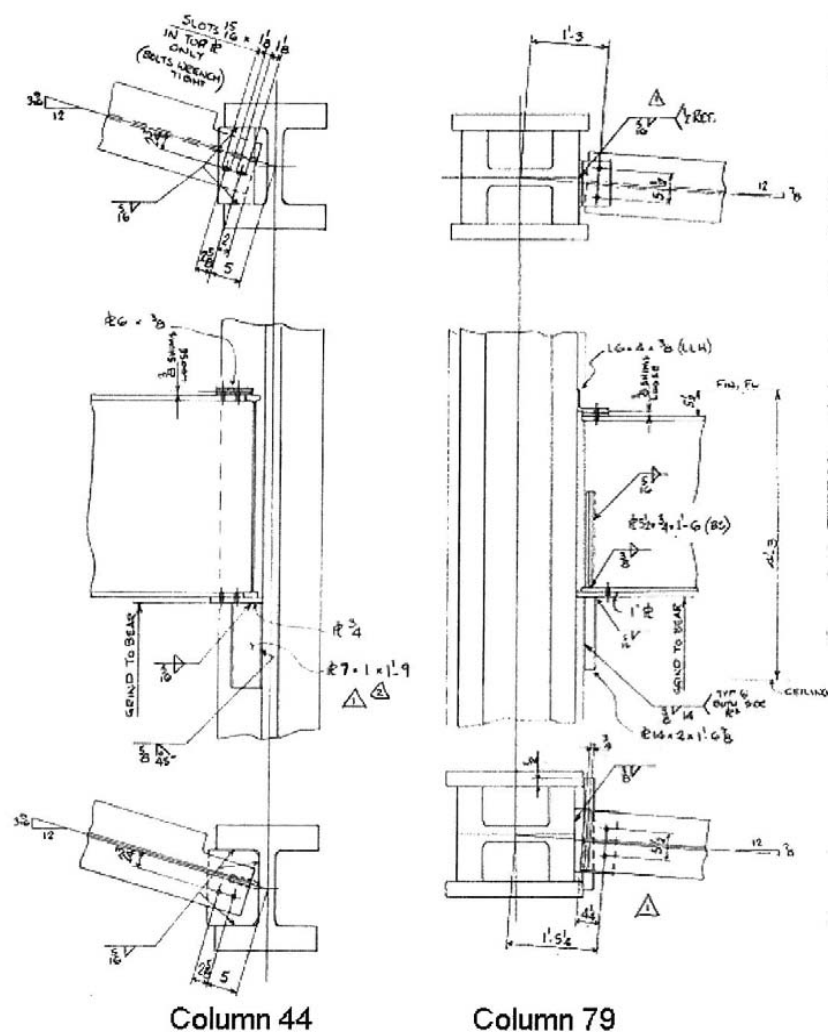
Figure 12 Details of seated connections at columns 44 and 79

The details of the seated connections at columns 79 and 44, between the 8<sup>th</sup> to 15<sup>th</sup> floors, are shown in Figure 12, which are taken from Frankel Steel Shop Drawing Numbers 9102 and 9114.

The connections have four bolts (7/8in A325) at each end, 2 fixing the girder to the bottom seat and 2 fixing the girder to the top cleat, with an overall shear capacity of 180kip. From the fabrication drawings it can be calculated that the gap between the end of girder and the columns is a total of 3.5in, with the length of the girder being 537in. (Frankel Steel Shop Drawing Numbers 1352, 1090, 9102 and 9114).

This force far exceeds the strength of the bolts indicating that the bolts will fail below  $100^\circ\text{C}$  (i.e. very early in the fire).

Although a simple calculation, this gives an indication of the compression force on the connections as the girder expands which is only resisted by four 7/8in bolts, which will fail very quickly in a fire.

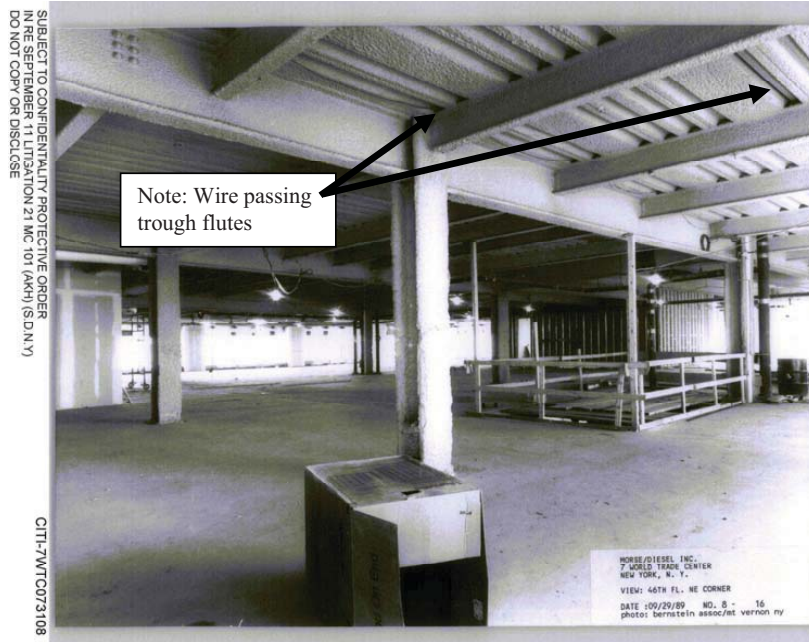
The construction of WTC7 was completed in 1987. These photographs were taken during 'fit-out' of the floors in 1989. They show that the flutes were not filled with fire protection as required. They also show in a number of cases wires being passed through the open flutes.

Figure A1: Photograph showing wire placed through flutes (46<sup>th</sup> Floor).

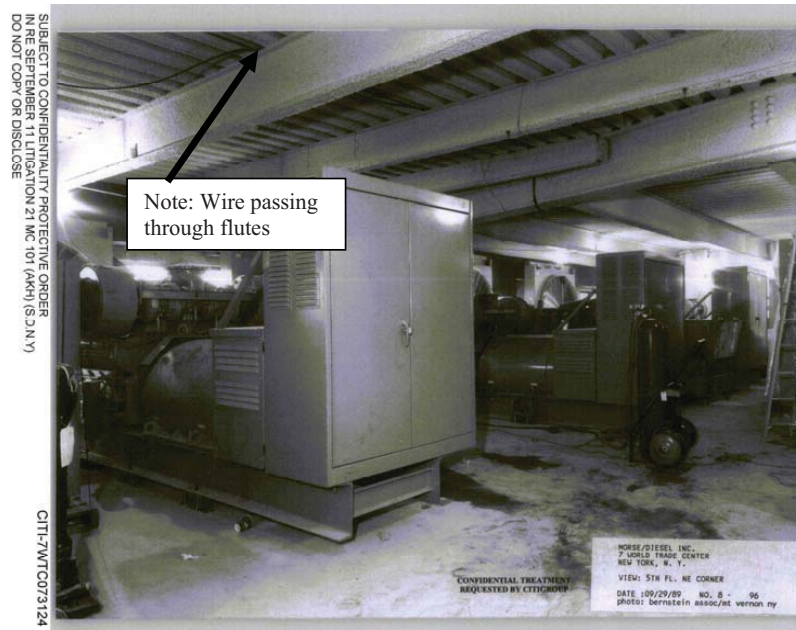
Figure A2: Photograph showing wire placed through flutes (5<sup>th</sup> Floor).

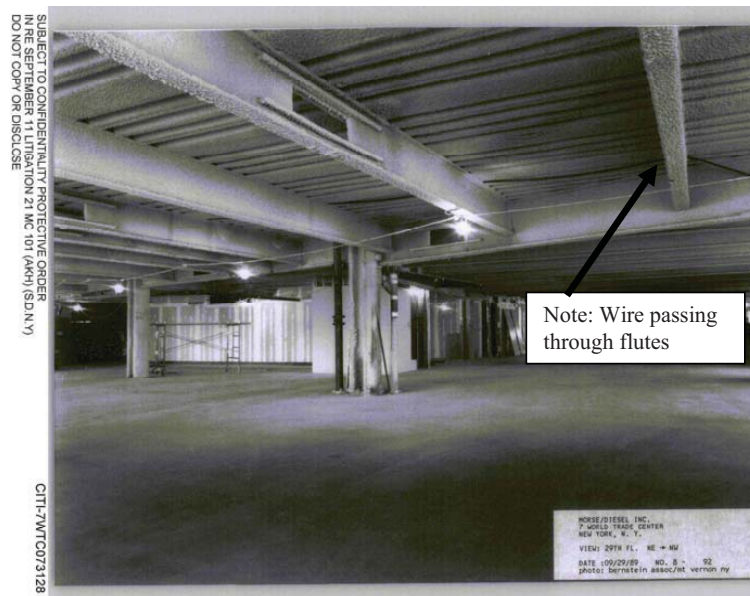
Figure A3: Photograph showing wire placed through flutes (29<sup>th</sup> Floor).

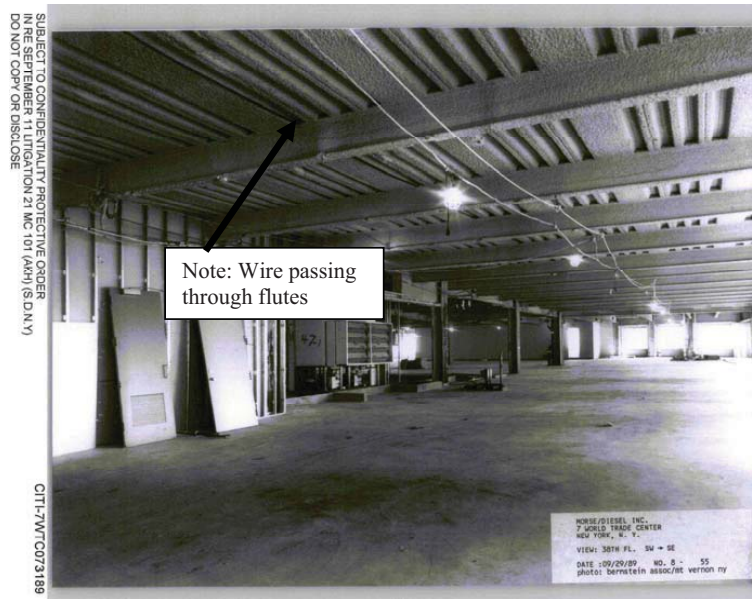
Figure A4: Photograph showing wire placed through flutes (38<sup>th</sup> Floor).

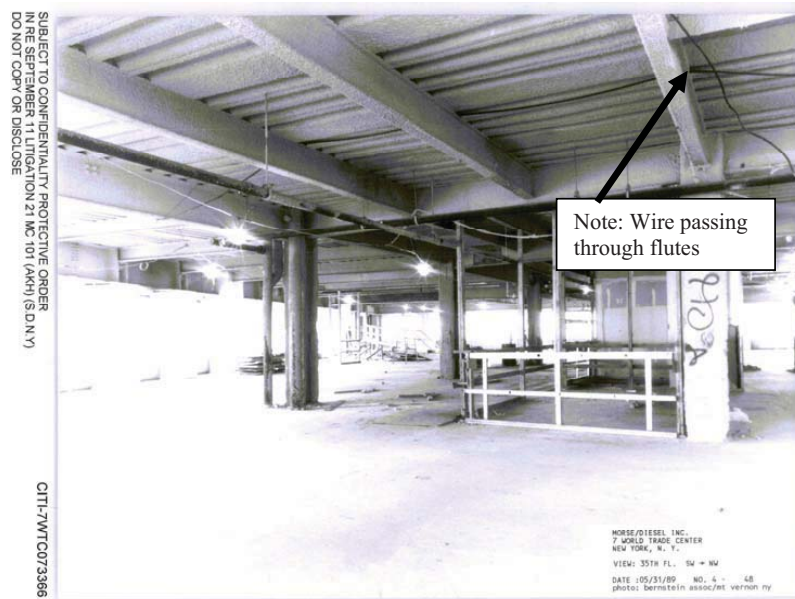
Figure A8: Photograph showing wire placed through flutes (35<sup>th</sup> Floor)

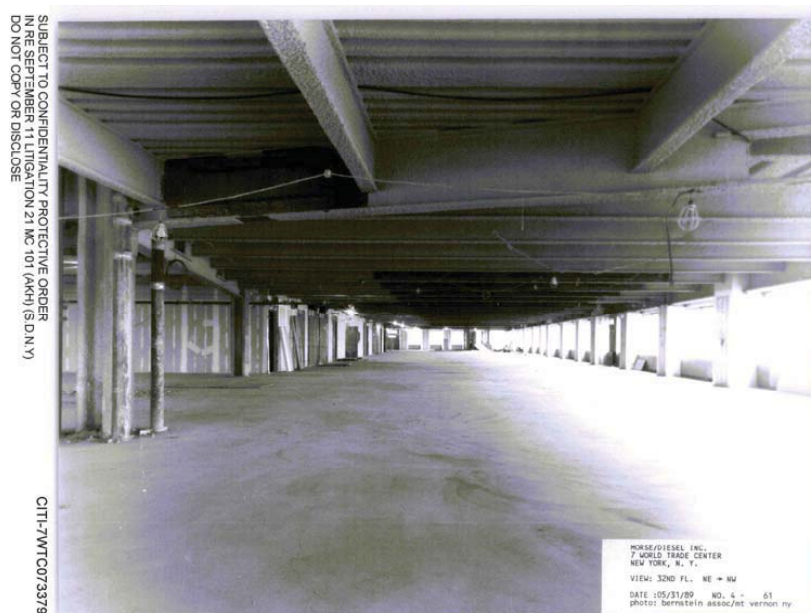
Figure A9: Photograph showing wire placed through flutes (32<sup>nd</sup> Floor)

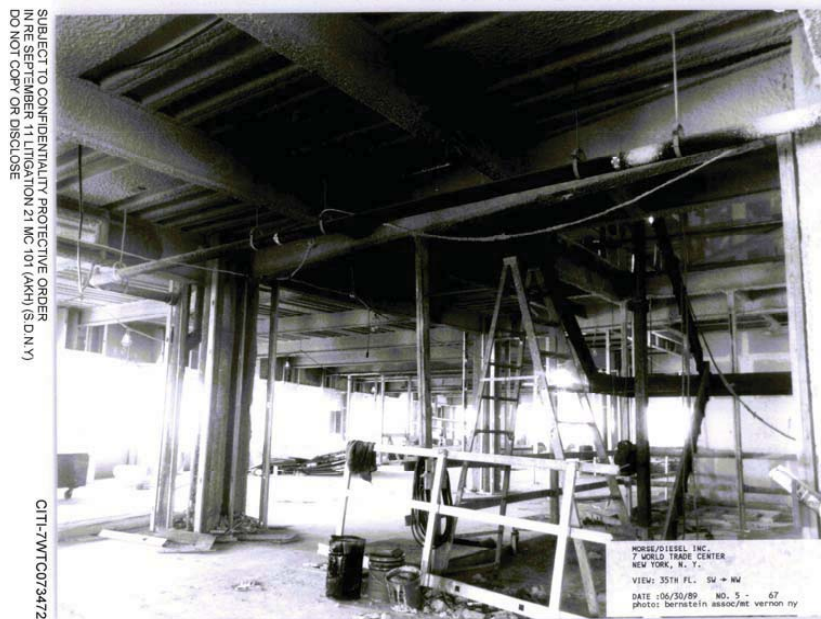
Figure A10: Photograph showing wire placed through flutes (35<sup>nd</sup> Floor)

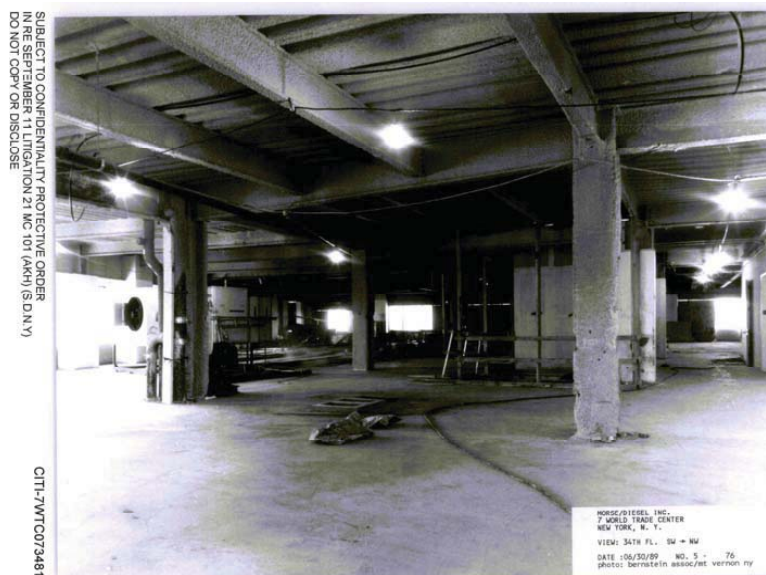
Figure A11: Photograph showing wire placed through flutes (34<sup>th</sup> Floor)

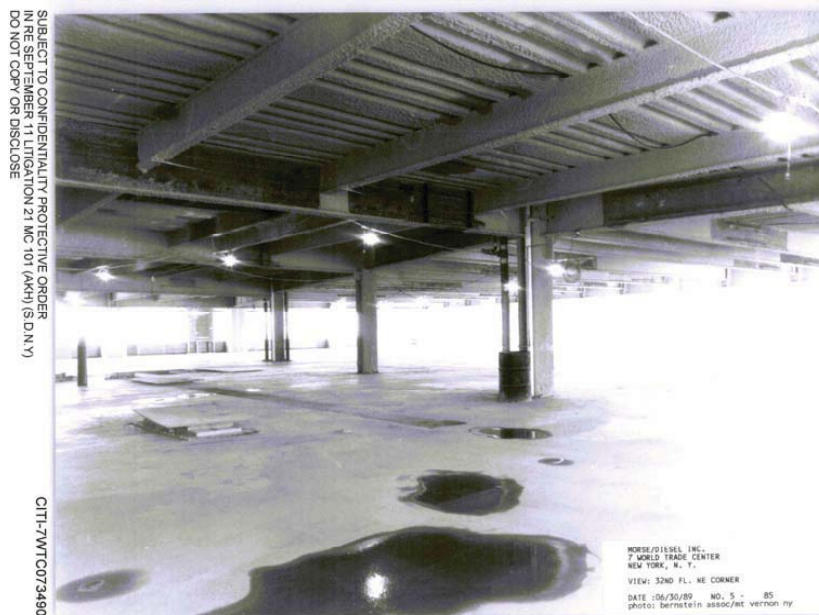
Figure A13: Photograph showing wire placed through flutes (32<sup>nd</sup> Floor)

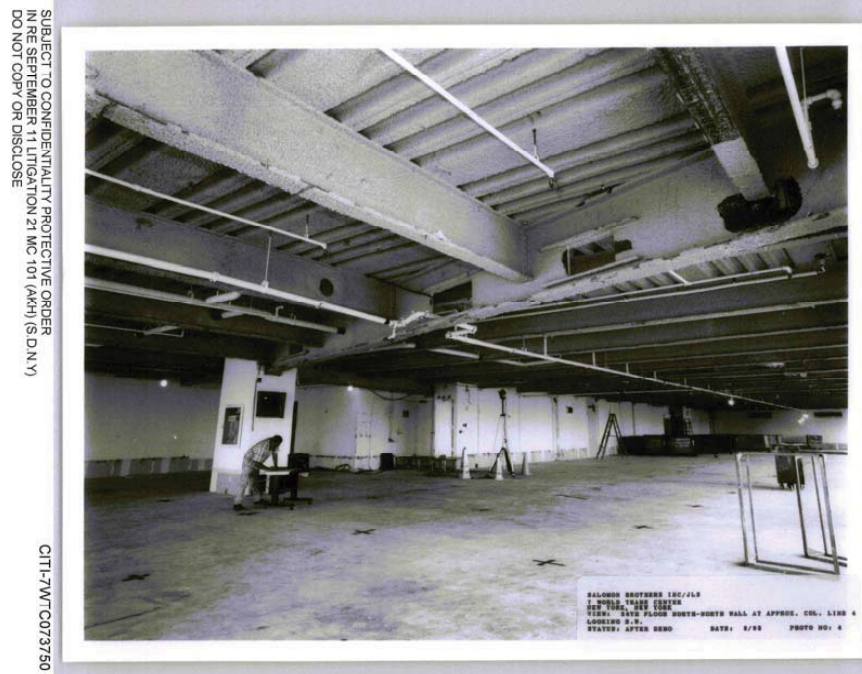
Figure A16 Photograph on 24<sup>th</sup> floor showing unfilled flutes above girder

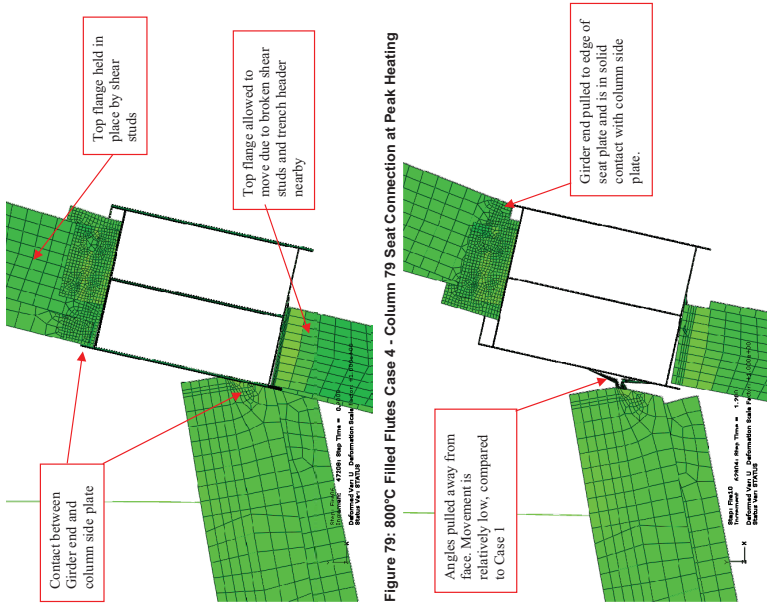
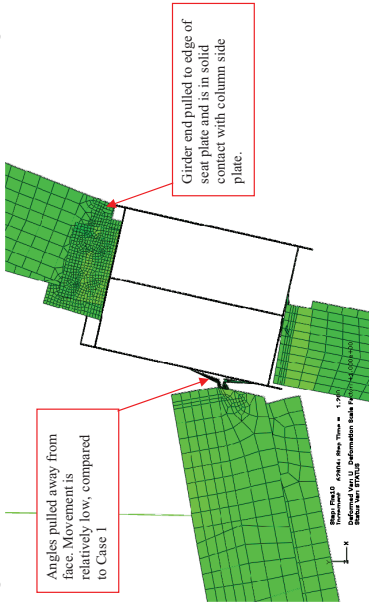
The movement of the 3 connections around Column 79 are imaged in Figure 78, Figure 79 and Figure 80. These images are taken at ambient, peak heating and the end of cooling.

- Seating bolts break early in the fire due to longitudinal expansion of Girder 79-44. The bolts in the top clip break shortly thereafter.
- End of girder is then free to be moved about on the seating plate. This movement is consistent with the response seen in the other three cases analysed.
- Toward the middle of the heating phase the girder end is jammed into the corner between the column flange and the extension of the column side plate beyond the flange.
- As the structure begins to cool the contraction of the structure pulls the end of Girder 79-44 eastward across the seating plate at Column 79.
- At the end of cooling the girder end is solidly seated and in good contact with the column side plate.

Figure 78: 800°C Filled Flutes Case 4 - Column 79 Seat Connection at Ambient

Figure 79: 800°C Filled Flutes Case 4 - Column 79 Seat Connection at Peak Heating

Figure 80: 800°C Filled Flutes Case 4 - Column 79 Seat Connection at End of Cooling

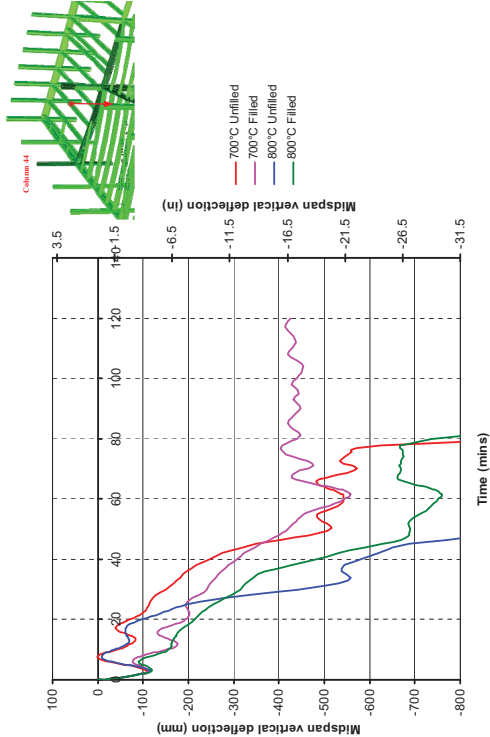
Figure 92 shows the comparison of vertical deflection at the mid-span of Beam 120 in the north-east bay for all four fire cases. This shows that runaway failure of this beam and resulting large deflections occur for all cases with the exception of Case 2 (700°C filled flutes). For Case 3 (800°C flutes unfilled), this runaway occurs late in heating and is linked to the general failure of Girder 79-44. For Case 1 (700°C flutes unfilled) and Case 4 (800°C flutes filled) runaway deflections are observed during cooling.

The reason for the observed runaway failure of the beam in the cooling phase for cases 1 and 4 is attributed to tension failure of its connection of the secondary beam at the eastern façade. Tension forces form in the secondary beams when the secondary beams (which have formed large vertical deflections) cool and contract.

Figure 92: Comparison of vertical deflection of mid-span of Beam 120 in the north-east bay for all four Cases

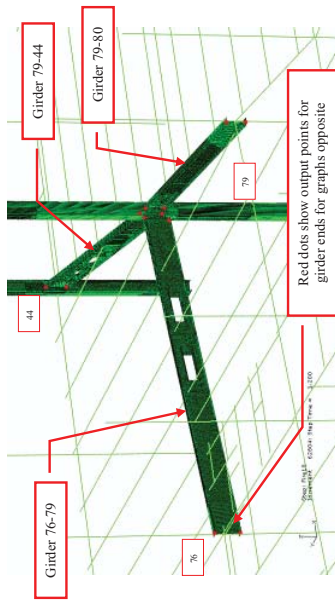
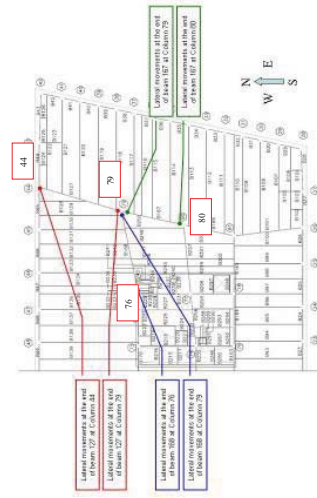
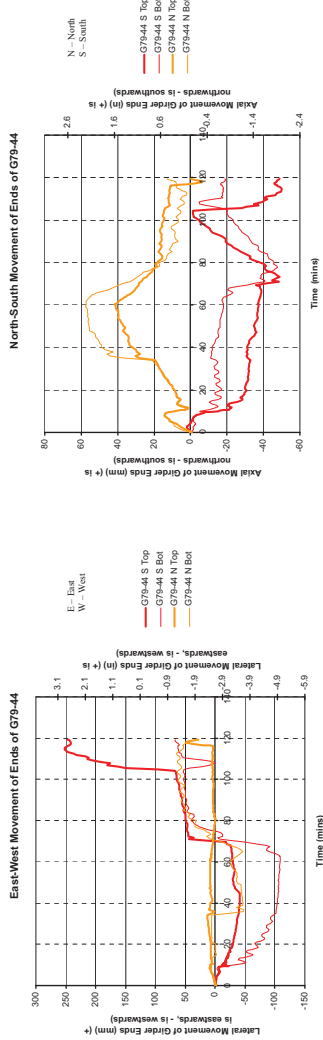
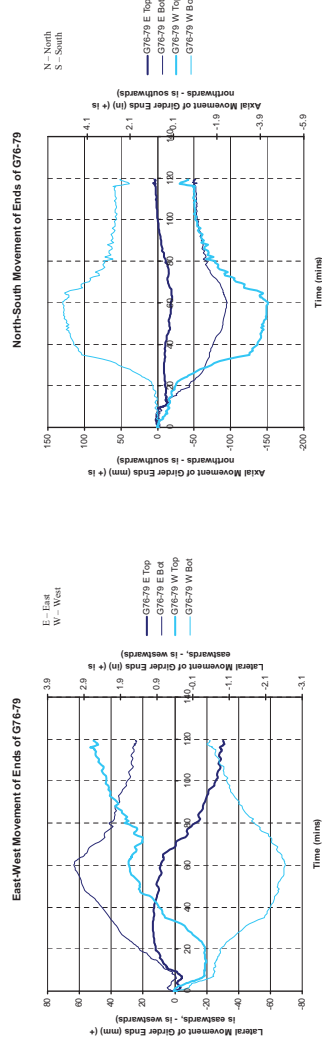
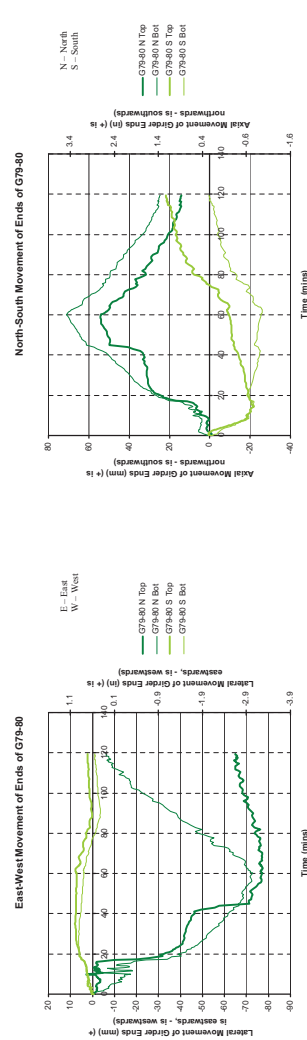
- **Girder 79-44**  
The girder is pushed and pulled laterally by the secondary beams to the extent that late in cooling it is sitting precariously on the eastern edge of its seat at Column 79.
- **Girder 76-79**  
As the girder expands and contracts with heating and cooling its movements are accommodated by ductility in the knife angle plates. Angle plates remain intact and do not tear.
- **Girder 79-80**  
As the girder expands and contracts with heating and cooling its movements are accommodated by ductility in the knife angle plates. Angle plates remain intact and do not tear.

Figure 97: Lateral movements (top and bottom) at each end of the girders framing into Column 79. Images on the left show the locations of the output points on each girder.

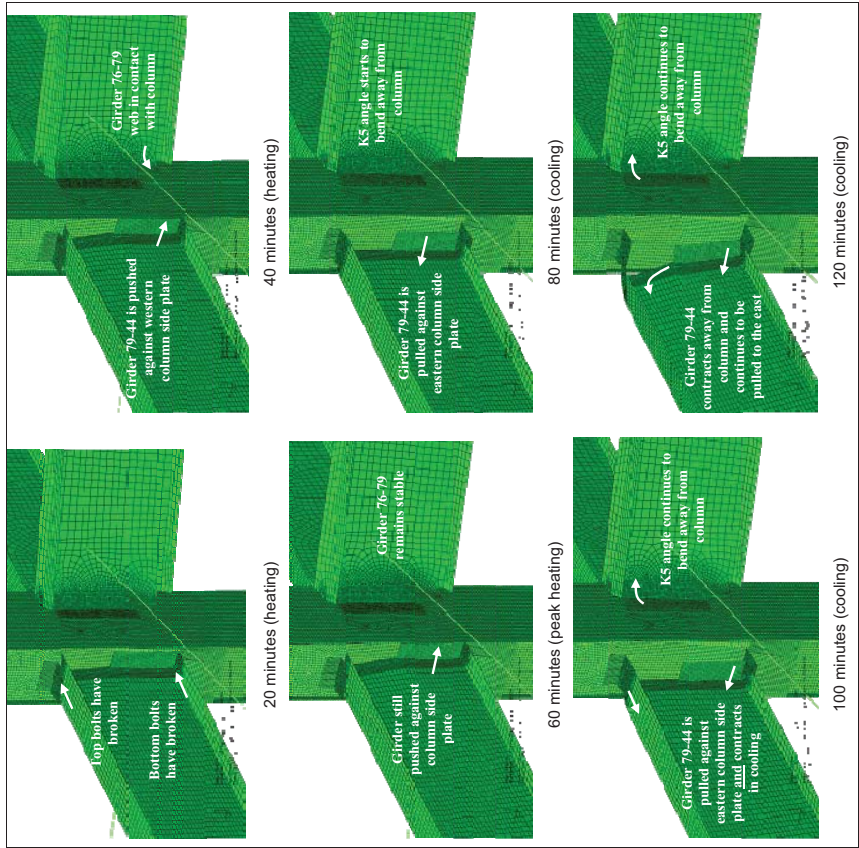
Figure 101: Deformed structure images of the seated connection at Column 79 and the K8 knife connection at 20 minute intervals throughout the fire

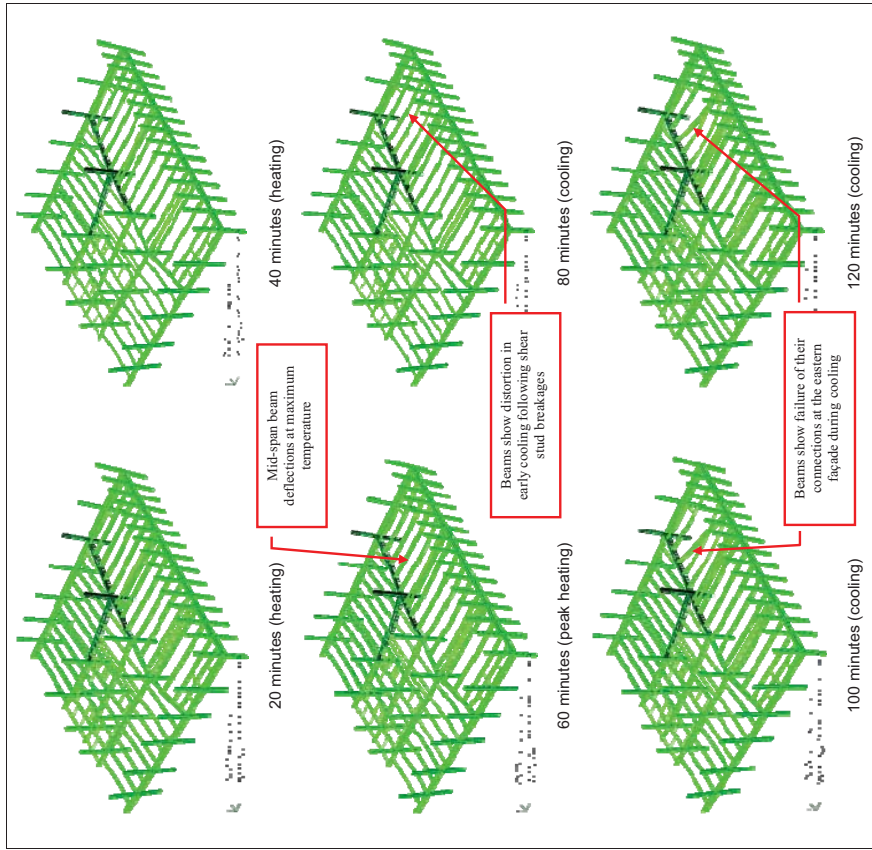
Figure 102: Deformed structure images of the structural frame in the north-east region of Floor 13 at 20 minute intervals throughout the analysis

Two secondary beams in the north-east bay fail at their connections to the eastern facade columns as the beams contract due to cooling and create large tension forces.  
Girder 79-44 is pulled across its seat plate during cooling by the secondary beams and is left resting precariously at the eastern side of this plate

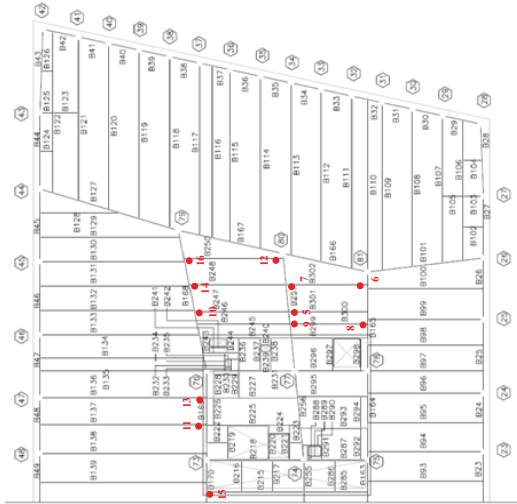
Figure 103 shows the location and sequence of connection failures observed during the analysis. Refer to Table 6 for times of failures.

Figure 103: Locations and sequence of connection failures (sequence numbers correspond to Table 6)

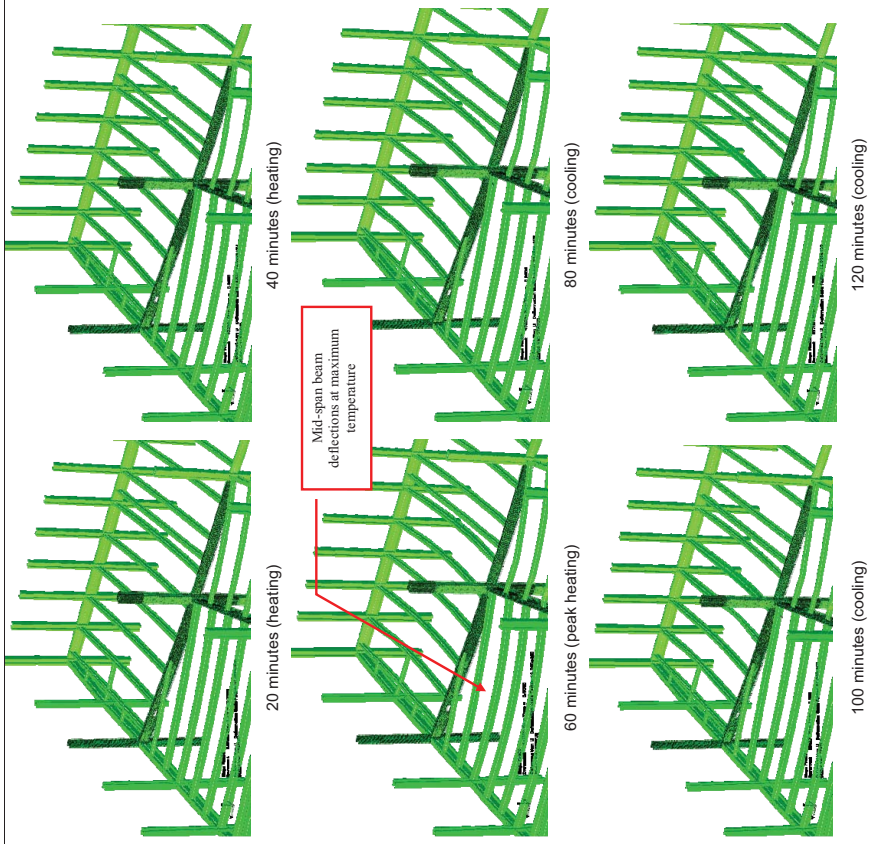
Figure 112: Deformed structure images of the structural frame in the north-east region of Floor 13 at 20 minute intervals throughout the analysis

The structural frame of Floor 13 remains stable throughout both the heating and cooling phases.  
The secondary beams and girders exhibit vertical deformations, some of which are partially recovered during the cooling phase.  
No initiating collapse mechanism is observed.

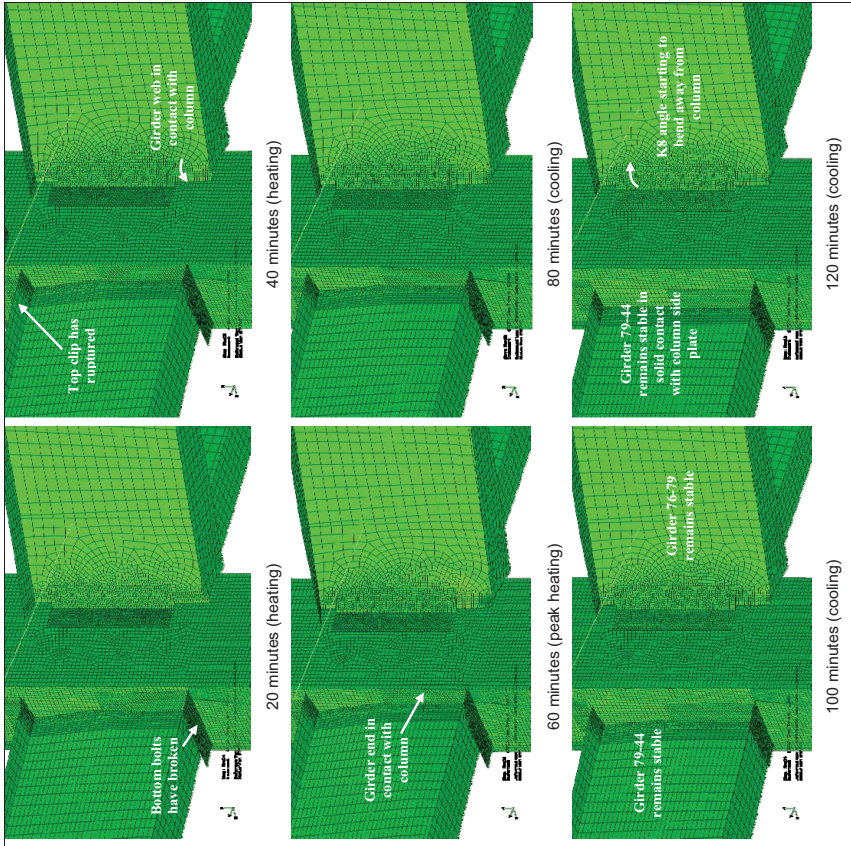
Figure 111: Deformed structure images of the seated connection at Column 79 and the K8 knife connection at 20 minute intervals throughout the fire

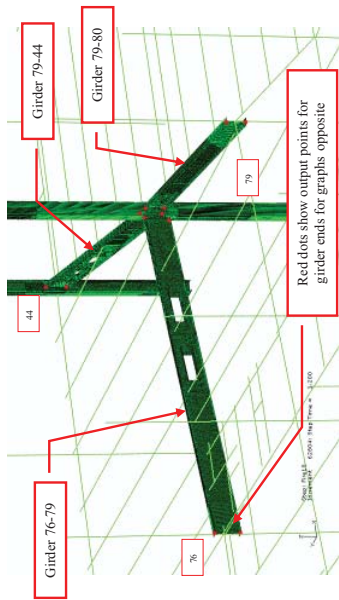
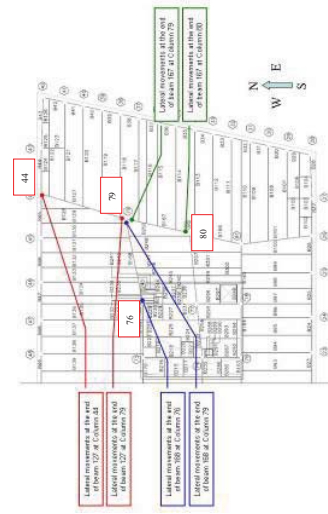
As the girder expands with heating its movements are accommodated by ductility in the knife angle plates. Angle plates remain intact and do not tear.

Figure 117: Lateral movements (top and bottom) at each end of the girders framing into Column 79. Images on the left show the locations of the output points on each girder.

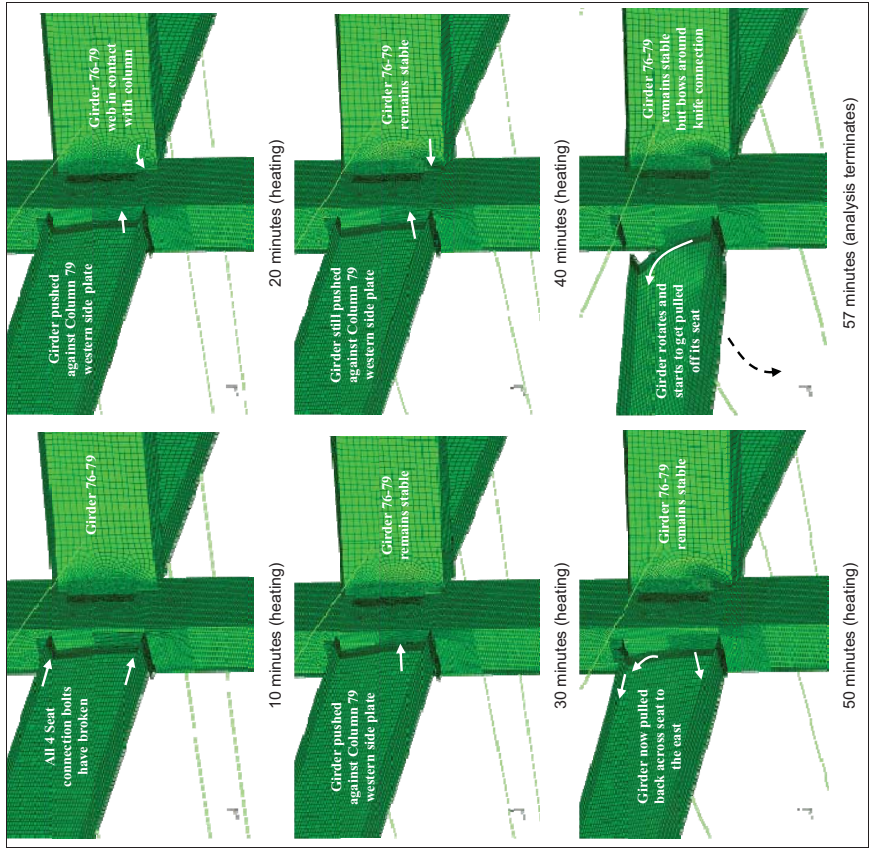
Figure 121: Deformed structure images of the seated connection at Column 79 and the K8 knife connection at 10 minute intervals throughout the fire

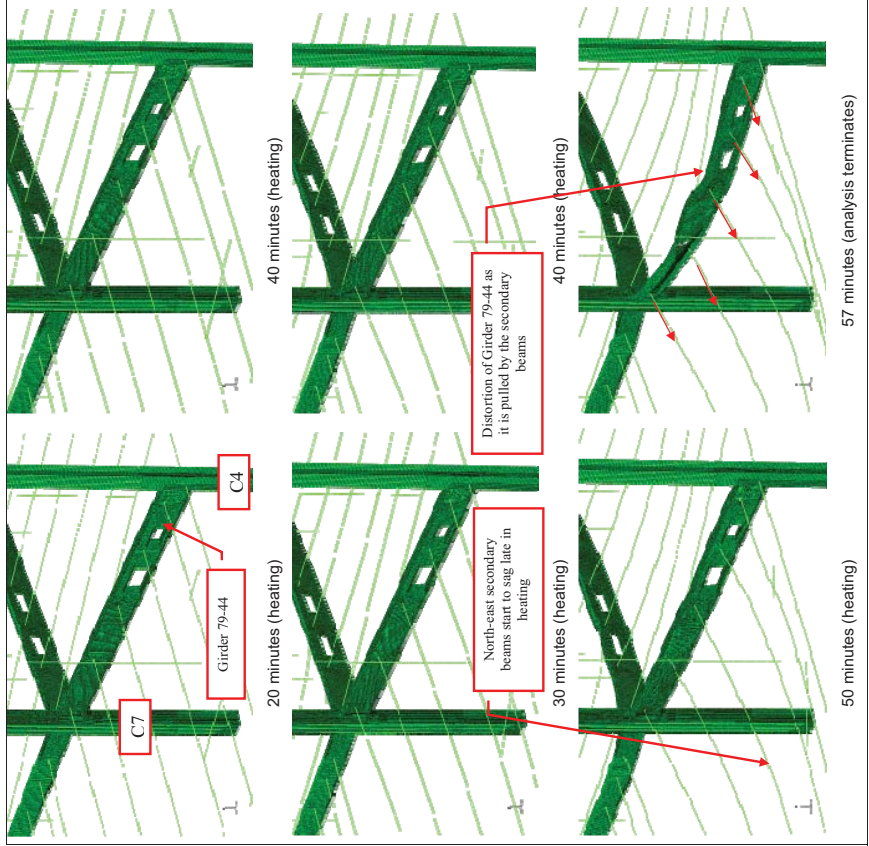
Figure 122: Deformed structure images of the Girder 79-44 in the north-east region of Floor 13 at 10 minute intervals throughout the analysis

Girder 79-44 is pulled across its seat plate late in heating by the secondary beams as they sag due to high temperature. The analysis terminated due to a numerical instability associated with the observed behaviour. The movement of the girder to the east at Column 79 forms the basis of a potential initiating collapse mechanism.

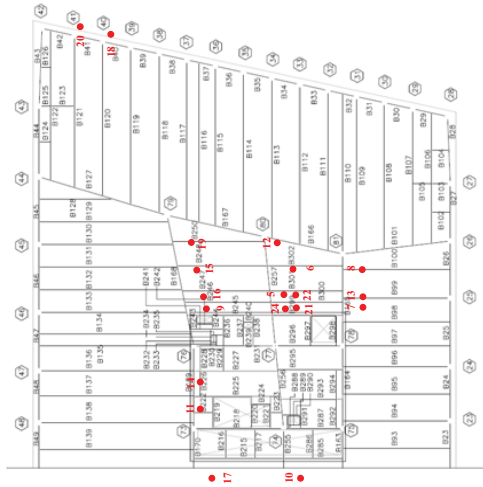
Figure 123 shows the location and sequence of connection failures observed during the analysis. Refer to Table 8 for times of failures.

Figure 123: Locations and sequence of connection failures (sequence numbers correspond to Table 6)

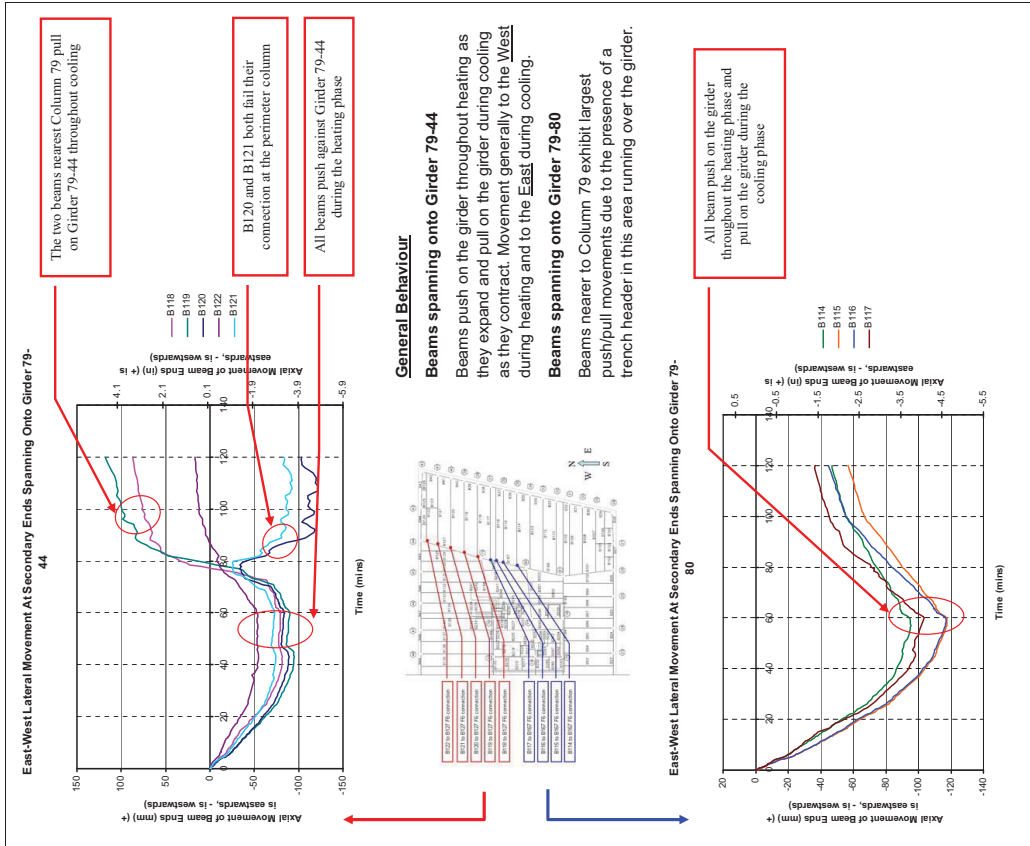
Figure 128: Lateral movements (east-west) of the western end of the beams framing into Girder 79-44 and Girder 79-80

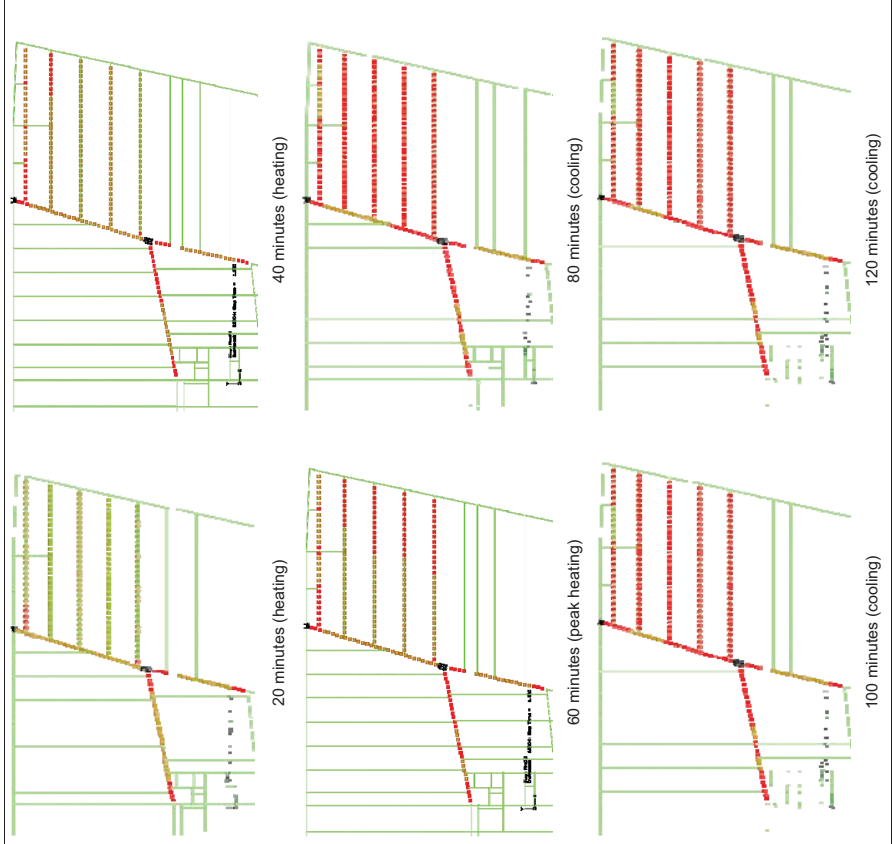
Figure 129: Shear stud failures within the north-east bay at 20 minute intervals throughout the duration of the analysis. Brown markers indicate unbroken shear studs while red markers indicate broken shear studs

During the heating phase of the fire, shear stud breakages are observed at either end of Girders 76-79 and 79-80 and also on the eastern third of beams in the north-east bay.

During the initial cooling phase, a significant number of shear studs break due to differential cooling between the concrete slab and the steel beams. These include almost all shear studs on the secondary beams and the majority on each of the three girders into Column 79.
