# 11-4403-cv

## United States Court of Appeals *for the* Second Circuit

### JOINT APPENDIX Volume 12 of 16 (Pages JA-3067 to JA-3320)

3. In 2007, I was retained by counsel for Plaintiffs in this case to provide expert analysis with respect to the cause of the global collapse of World Trade Center 7 on September 11, 2001.

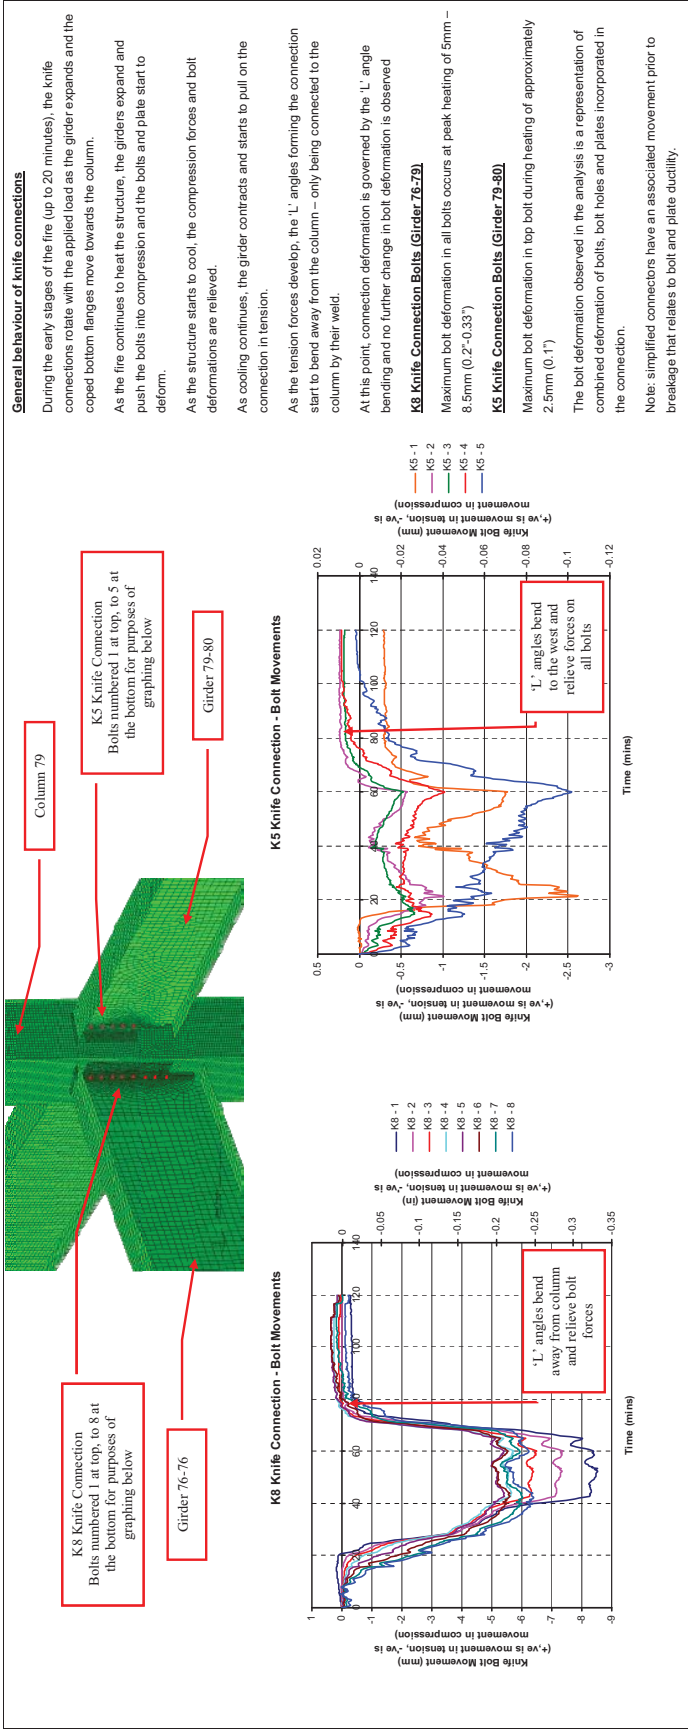
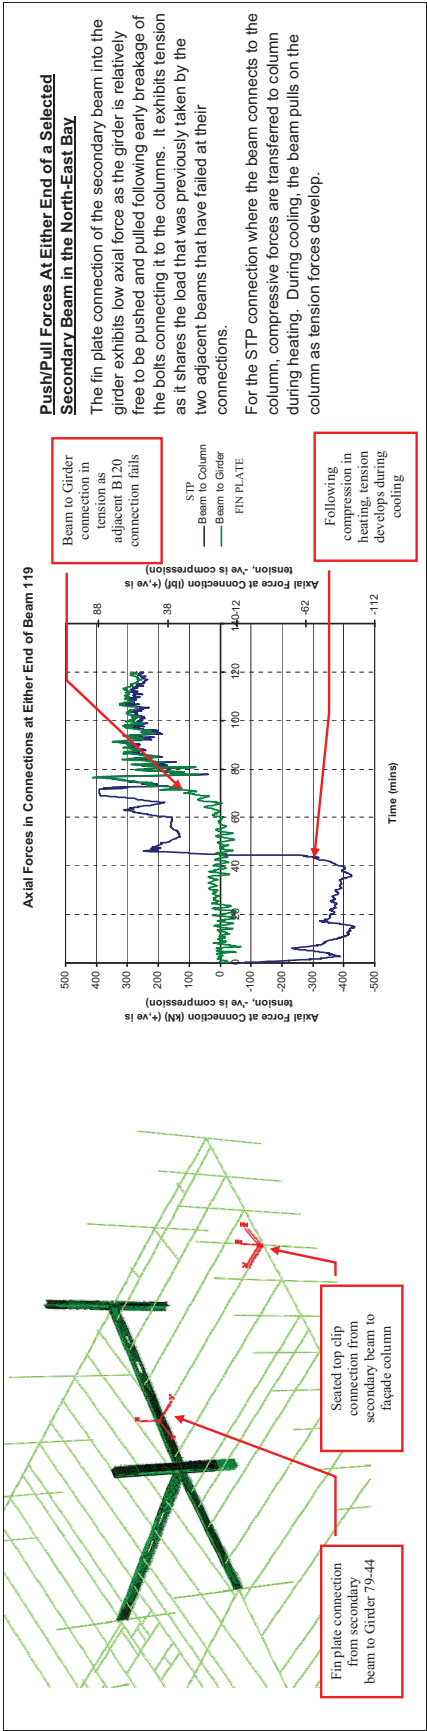
Figure 130: Lateral movement of knife connection bolts for the K8 and K5 knife connections. Also shown are the axial forces in the connections at the end of one beam in the north-east corner.

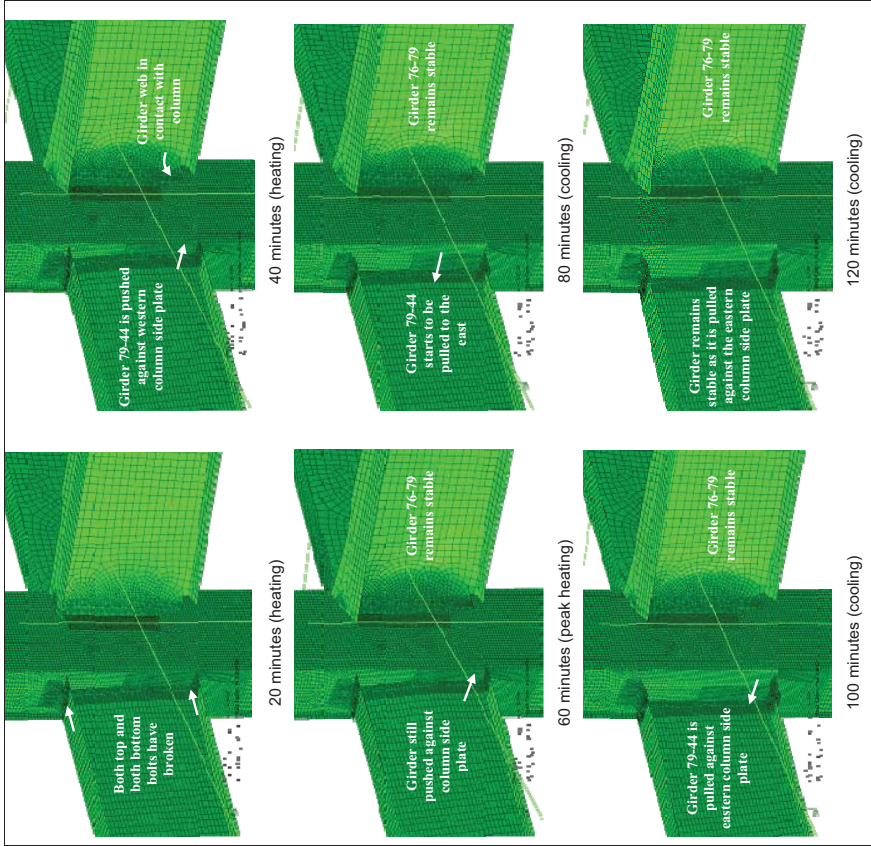
Figure 131: Deformed structure images of the seated connection at Column 79 and the K8 knife connection at 20 minute intervals throughout the fire

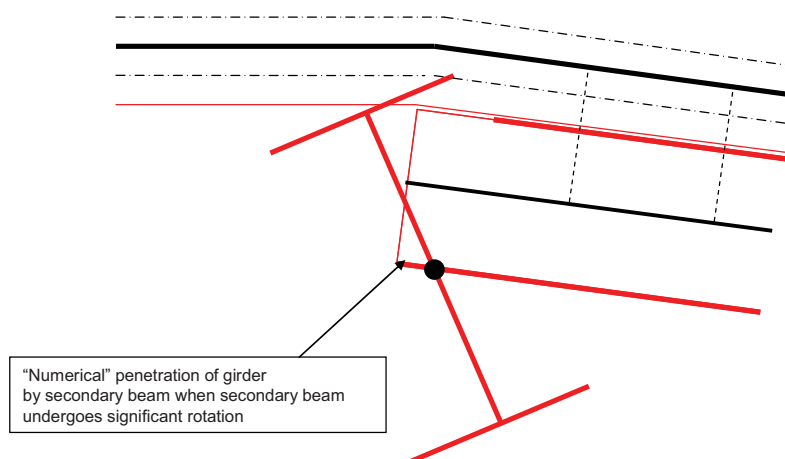
**Figure 162: Unrealistic structural responses**

For the detailed girders 44-79, 76-79 and 79-80 which support secondary beams on one side of each girder, Arup imposed a rotational limit to the ends of secondary beams to prevent unphysical "numerical" penetration of the girder web by the bottom flange of the secondary beam when the secondary beams rotate significantly, as indicated in Figure 162.

A maximum rotational limit of  $7^\circ$  of the ends of the secondary beams has been implemented by Arup by linking the rotation of the two nodes involved in the connector element. This is to simulate a more realistic structural response so after  $7^\circ$  of relative rotation between the end of the secondary beam and the girder, the beam end cannot rotate any further due to either the top flange or the bottom flange of the secondary beam bearing against the web of the girder, preventing any further relative rotation.

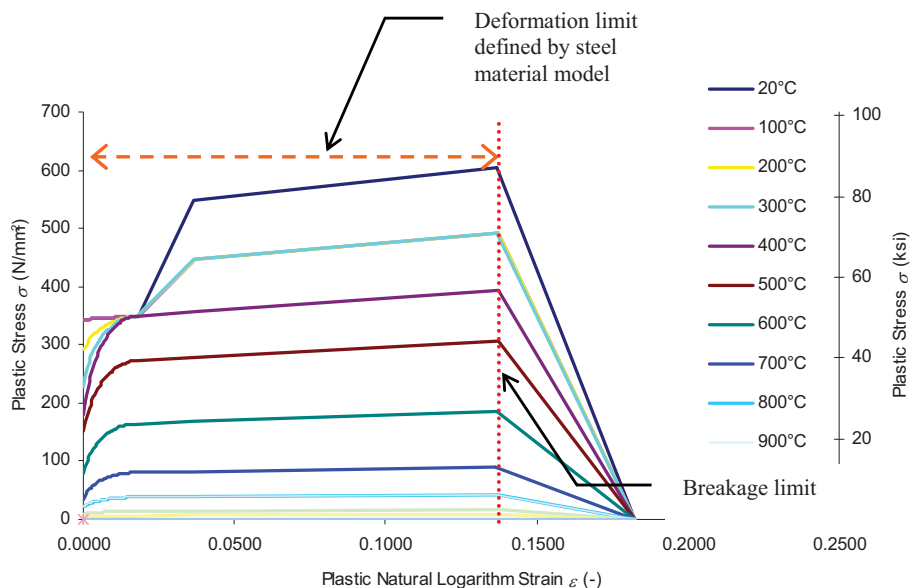
Figure 173 - Deformation and Breakage Limits for Shell Elements in Detailed connection model

For the detailed connections, the plates, clips, seats, and other connecting elements are modelled with shell elements. The deformation and breakage limits are captured explicitly in the ABAQUS analysis based on the stress-strain curves for the steel material model per Eurocode 3 **Error! Reference source not found.** (See Figure 173). That is, the deformation limit and breakage limit have been defined at 15% of the engineering strains (Note that this equates to a slightly lower strain value when converted to the true strains, as shown in Figure 173).

Note: In the ABAQUS model, a damage initiation feature is applied to the steel shell elements which physically allow the connection to rupture or break once the strain reaches the peak strain.

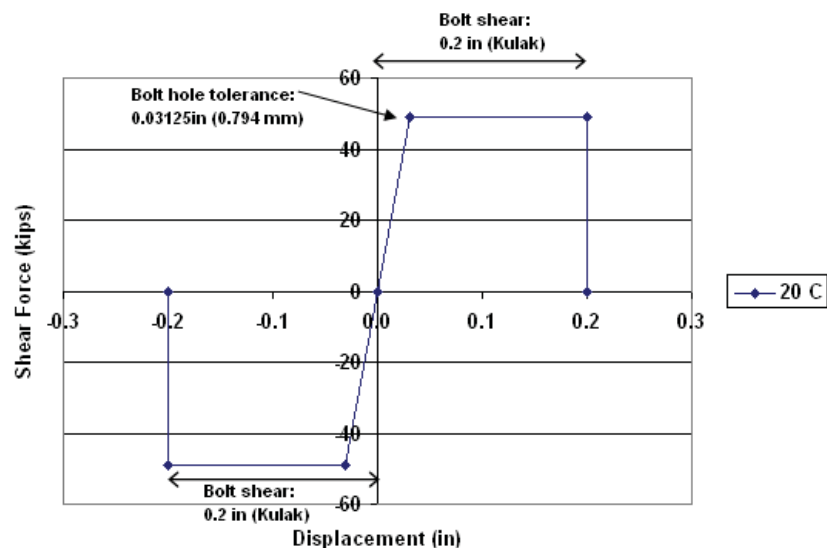
Figure 174 - A325 bolt shear force deformation curve (ambient)

The bolts at the seated connections (modelled in detail) at the end of the girder between Column 79 and Column 44 act in single shear. Figure 174 and Figure 175 illustrates the shear deformation and breakage limits for the bolts in ambient and fire conditions. The shear deformation limit at ambient conditions is 0.2 inch and is based on typical tests of A325 bolts as described in Kulak et al, 1987 **Error! Reference source not found.**

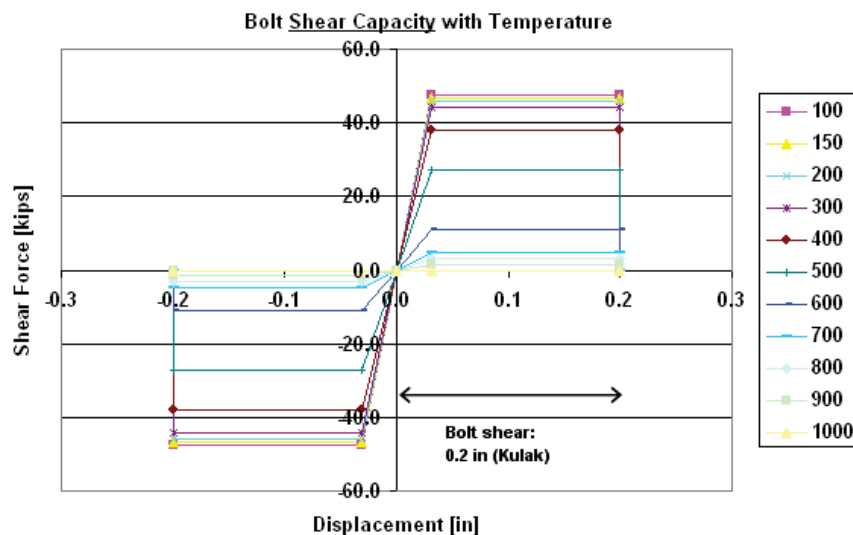
Figure 175 - A325 bolt shear force deformation curves (fire)

For fire conditions, the deformation limit for the bolts acting in single shear is equal to that defined for ambient conditions (0.2 inch) as shown in Figure 174, as limited test data is available to justify an increased ductility limit in fire conditions (British Steel, 1992 **Error! Reference source not found.**). That is, no increase in ductility of the bolt is considered at elevated temperatures.

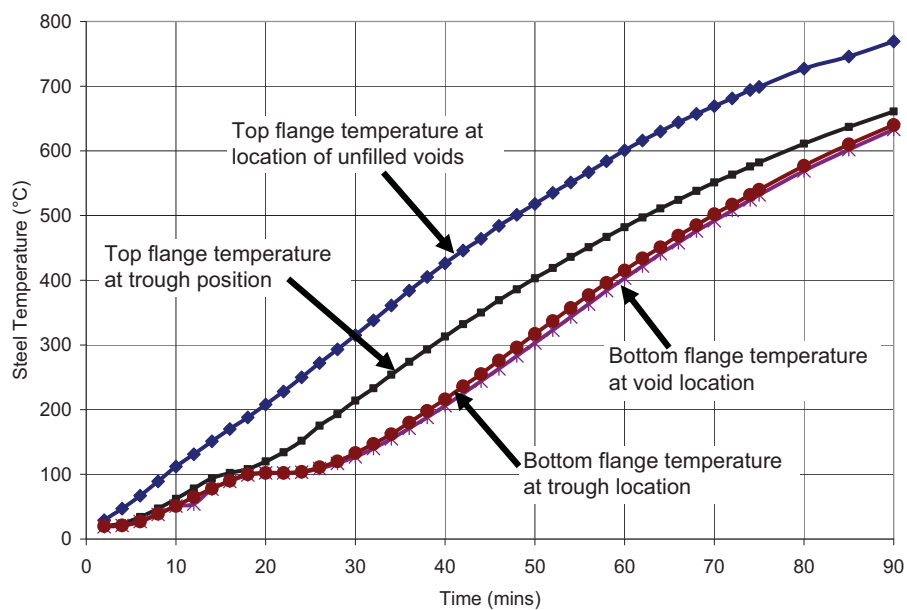
The temperatures recorded for Test 3 on the top flange (at the unfilled void location and trough location) and the bottom flange are shown in Figure C6. It can be seen that the top flange temperatures at the unfilled void location are greater than the temperatures at the trough location. In addition the top flange temperatures are greater than the bottom flange temperatures. If the voids were filled the top flange temperatures would be lower than the bottom flange temperatures. This was shown in Test 1, which had filled voids, with the temperatures shown in Figure C7.

Figure C6: Steel temperatures for Test 3; cementitious spray and voids unfilled.

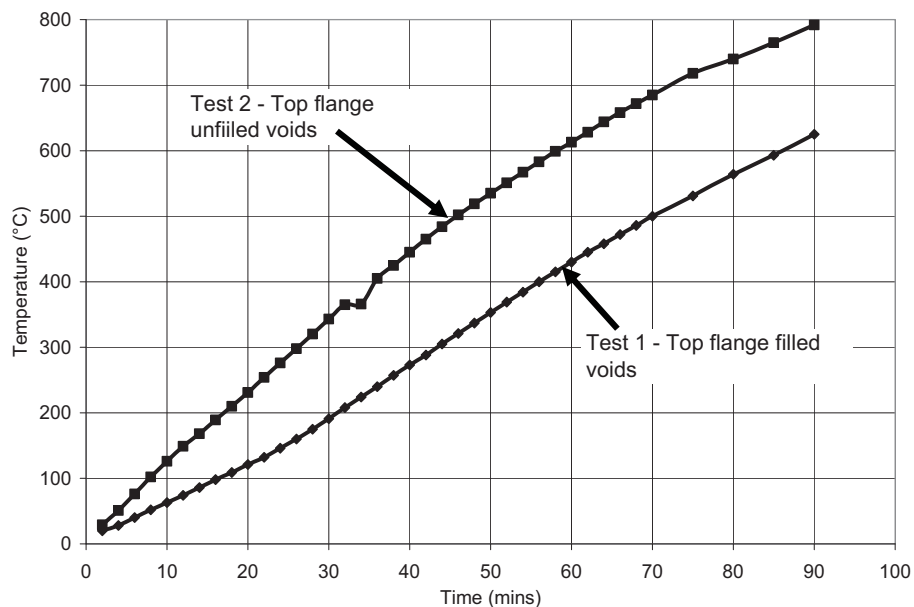
One interesting comparison is between Test 1 and Test 2, which although had a board protection, shows the direct comparison between filled and unfilled voids. The difference in top flange temperature is shown in Figure C8.

Figure C8 *Difference of top flange temperatures for Test 1 (filled voids) and Test 2 (unfilled voids)*

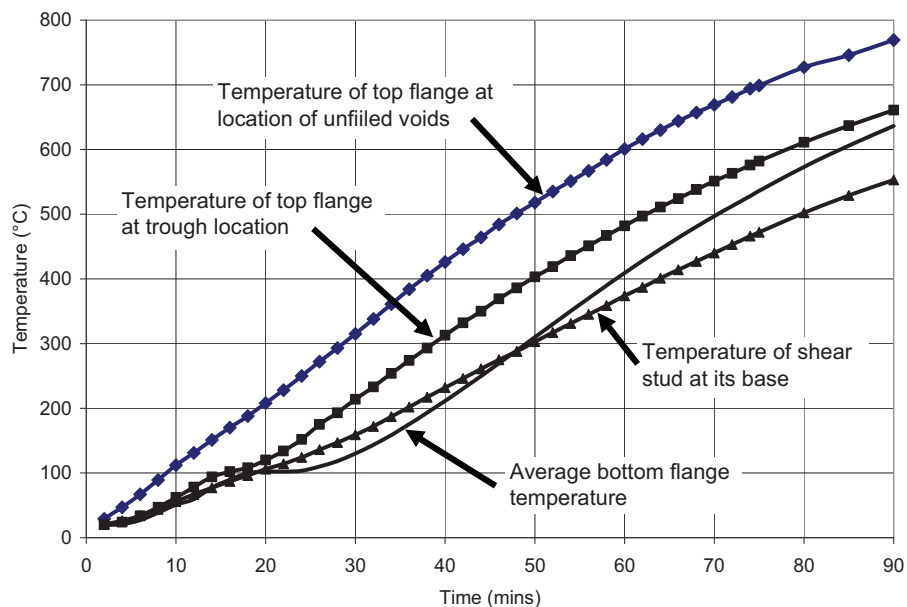
In the series of tests the temperature of the shear studs were measured. The temperature at the base of the shear stud in Test 3 is shown in Figure C9, where it can be seen that the stud temperature is only 84°C lower than the bottom flange temperature at 90 mins.

Figure C9 Stud temperature and steel temperature for Test 3

The shear stud temperatures are significantly higher when the voids are unfilled leading to the possibility of shear stud failure. It should also be noted that the studs in the reported tests were placed in the centre of the trough whereas in practice they would be placed off-centre leading to even higher temperatures.

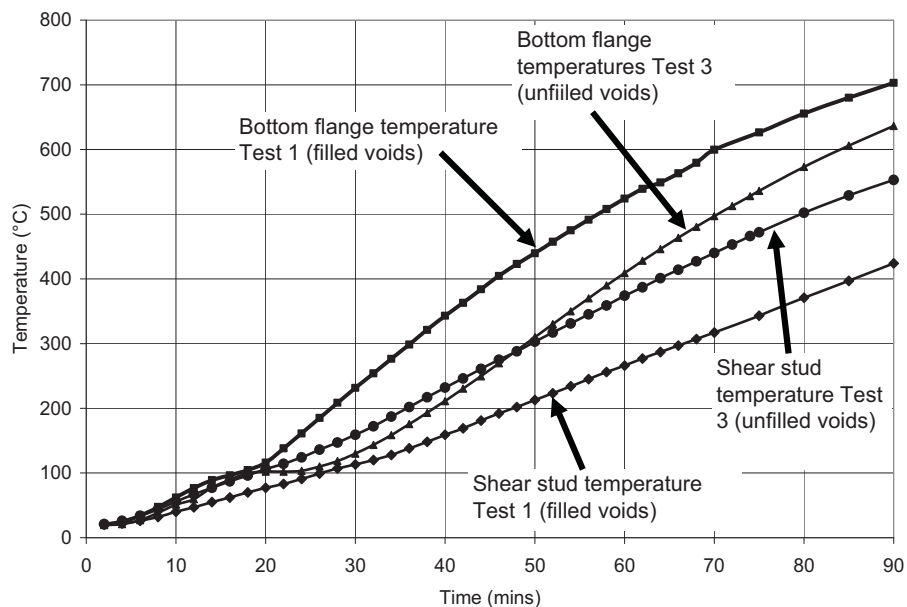
As a comparison for Test 1, the stud temperature is significantly lower than the bottom flange (279°C) at 90mins. A comparison between the bottom flange temperatures and shear stud temperatures for Tests 1 and 3 is shown in Figure C10. It is important when considering Figure C10 that comparisons are only made between stud and bottom flange temperatures and not between tests, since different fire protection systems are used.

Figure C10 Comparison between bottom flange temperatures and stud temperatures for Tests 1 and 2.

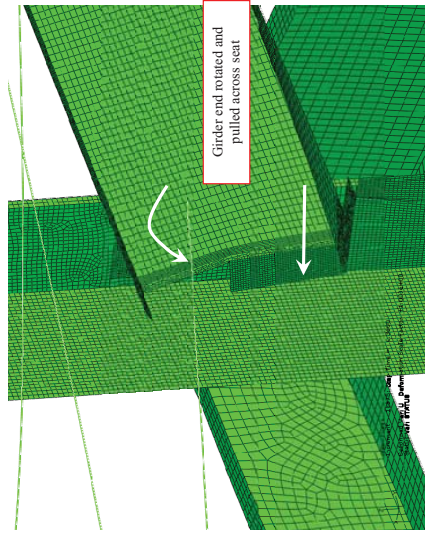
- Finally, at the end of 120 minutes of heating and cooling the end of the girder is sitting precariously at the side of the seat (Figure 17).  
The structural response described above is presented in more detail in the following sections. A more detailed timeline may be found in Section 5.5.

Figure 17: 700°C Unfillet Flutes Case 1 - Column 79 Seated Connection at End of Cooling

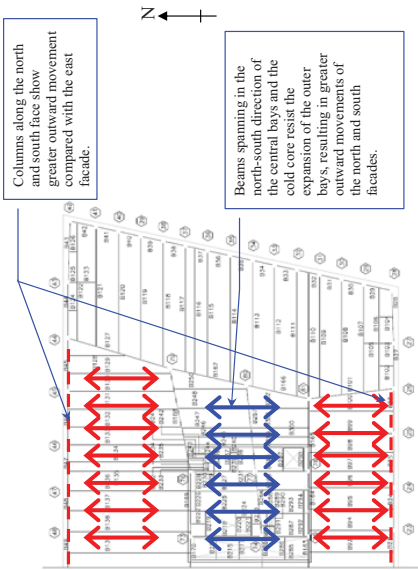
Figure 20 indicates the location of the columns being compared. The greater outward movement of the north and south façade columns is attributed to the thermal expansion of the north-south beams spanning onto these columns (Figure 21), which is resisted by the beams in the central bays and the cold core.

Figure 21: Mechanism which causes the greater observed movement of the north and south façades

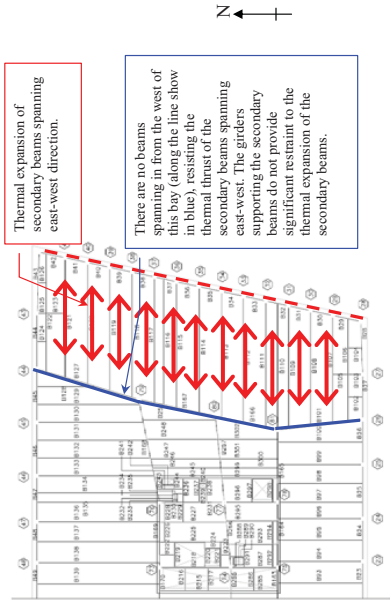
As there are no beams on the west side of the girders running between columns 44-26, there is no axial resistance to the thermal expansion of the secondary beams. Therefore, the thermal expansion of these secondary beams occurs in both the girders, and the eastern façade columns, thus resulting in comparatively smaller outward movement of the eastern façade (Figure 22). This means that the floor in these outer bays is relatively unrestrained, when compared to the bays with beams spanning north-south.

Figure 22: Mechanism which causes the smaller observed movement of the eastern façade

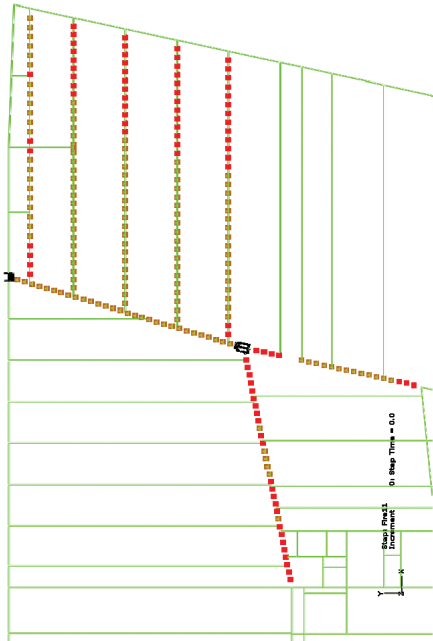
During the heating phase of the WTC7 analysis less than half the available shear studs in the north-east bay fail (Figure 24). This indicates that composite action is still largely available, assisting the strength and stiffness of the structure.

Figure 24: 700°C Unfilled Flutes Case 1 - Shear Stud Breakage (highlighted as red dots) at Peak Heating. Intact shear studs are shown in brown.

- Figure 61 indicates the shear studs that have broken in the Case 3 model when Girder 79-44 top flange temperature is approximately 640°C (40 minutes into the heating phase) and again the pattern is extremely similar to that of the Case 1 model at peak heating (please refer to Figure 24 for comparison).

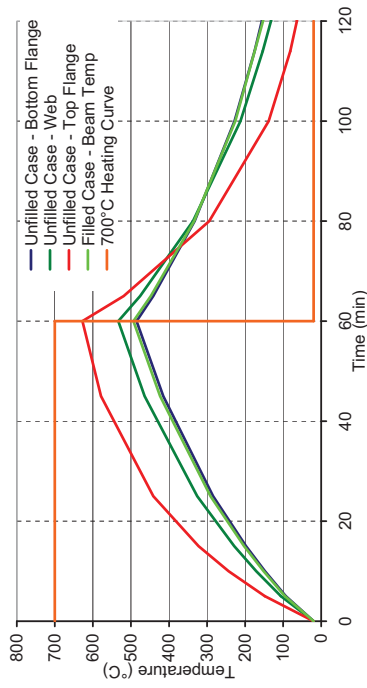
An example of heating in different parts of a beam is indicated in Figure 26. This figure shows the difference between a fully protected beam and a beam with unfilled flutes, as occurs in Case 1. Significant differences in temperature between the top and bottom flange are introduced due to the unprotected top surface of the top flange.

Figure 26: Comparison of temperatures of a typical beam/girder with flutes filled and unfilled condition.

In the 700°C fire case with unfilled flutes the top flange reaches approximately 675°C, indicating that if composite action has been fully lost then the north-east corner beams will fail during heating. This is not observed in the model, and therefore composite action must still exist to some degree, even if some shear studs have been broken.

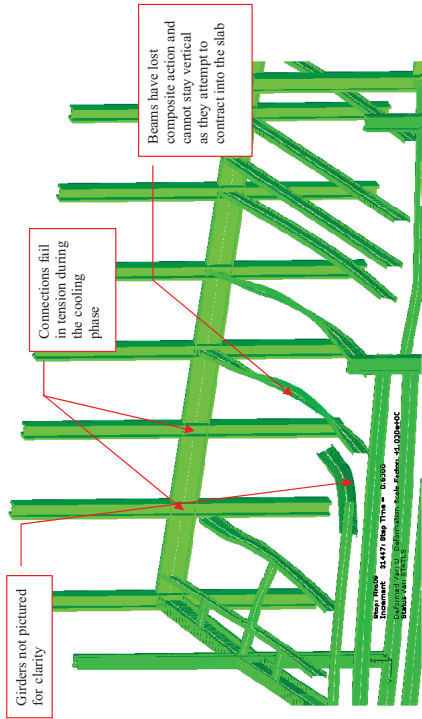
As indicated in Figure 27 the loss of composite connection between the slab and beams can lead to the secondary beams rotating around their long axis, reducing their bending strength.

Figure 27 also indicates that the large tensile forces developed as the secondary beams contract against the slab are sufficient to rupture their connections leading to local failure.

Figure 27: 700°C Unfilled Flutes Case 1 - Beam Orientation During Cooling Phase (90 minutes, Girders not pictured for clarity)

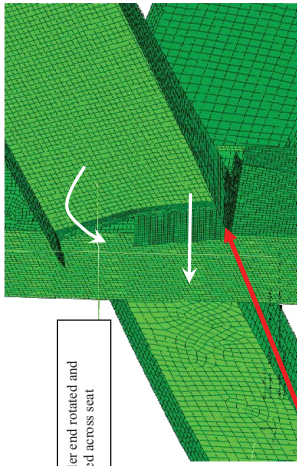
| Event | Time Mins | Location and failure comments | Girder 79-44 Top Flange Temp °C |
|---|---|---|---|
| 10 | End | Mid-span deflection of secondary beams leads to the girder tending to rotate. This effect combines with the contraction of the secondary beams during the cooling phase to pull and rotate the end of the girder back across the seating plate. | 81 |

Figure 40: 700°C Unfilled Flutes Case 1 - Column 79 Seat Connection @ End Cooling

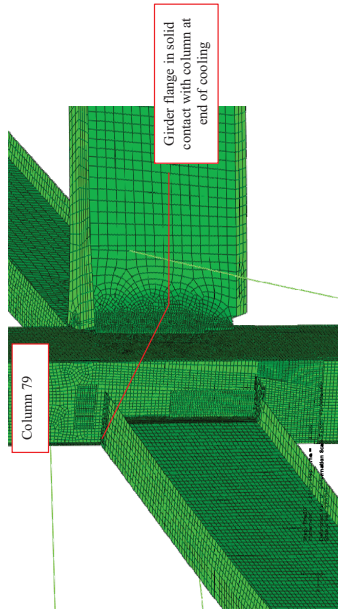
Figure 41: 700°C Filled Flutes Case 2 - Seated connection of girder 79-44 at the end of cooling

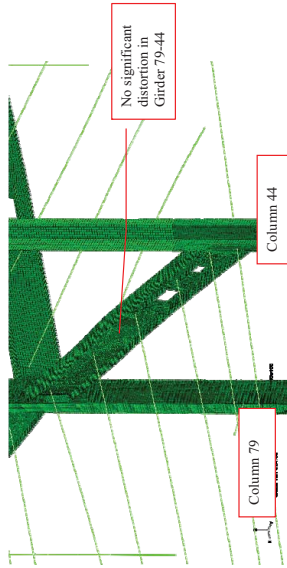
Figure 42: 700°C Filled Flutes Case 2 - Girder 79-44 at the end of cooling

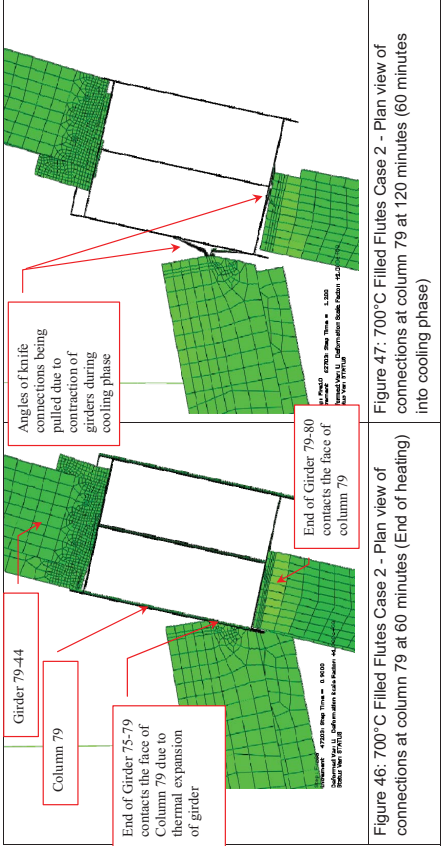
- During the heating phase, as the girders expanded, the connections are subjected to compression forces from the expanding girders and the angles experienced local bending. As the girders expanded and were thrust into the column, there was some local twisting of the girder ends as shown in Figure 46.
- During the cooling phase, as the girders started to cool and contract, the angles of the connections were subjected to tension forces from the girders and were pulled away from the surface of the column 79 (Figure 47).
- In both the heating and cooling phase, there was no breakage of the bolts or tearing of the plates.

Figure 46: 700°C Filled Flutes Case 2 - Plan view of connections at column 79 at 60 minutes (End of heating)

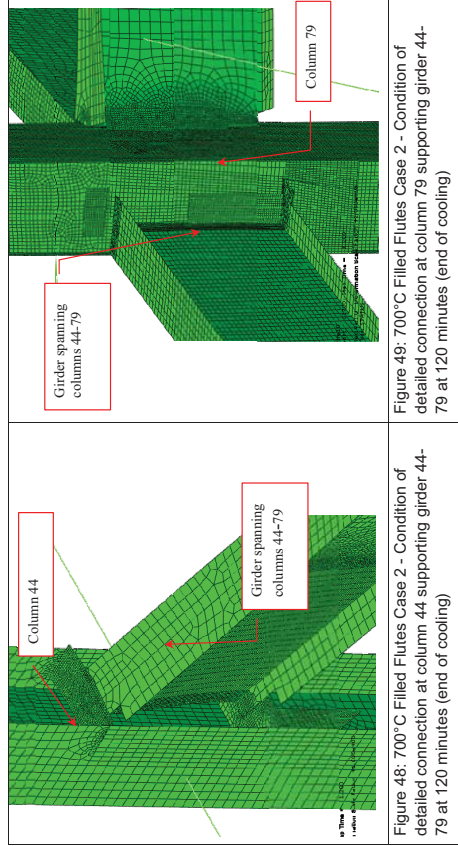
In Case 2, after 60 minutes of cooling, Girder 79-44 did not exhibit the kind of twisting deformation at column 79 (refer to Figure 49) that was observed in Case 1. This is due to the top flange of the girder remaining in solid contact with the column side plate throughout cooling. At the end of cooling in Case 2 there was no indication that the end of the girder was close to being displaced off its seat at Column 79.

Figure 48: 700°C Filled Flutes Case 2 - Condition of detailed connection at column 44 supporting girder 44-79 at 120 minutes (end of cooling)

Figure 49: 700°C Filled Flutes Case 2 - Condition of detailed connection at column 79 supporting girder 44-79 at 120 minutes (end of cooling)

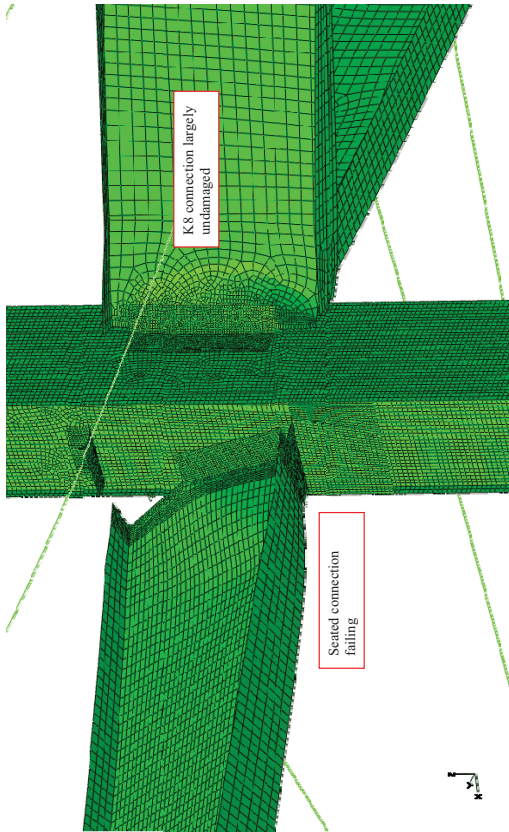
Figure 57: 800°C Unfilled Flutes Case 3 - Column 79 Seat and K8 Connections at Analysis Termination

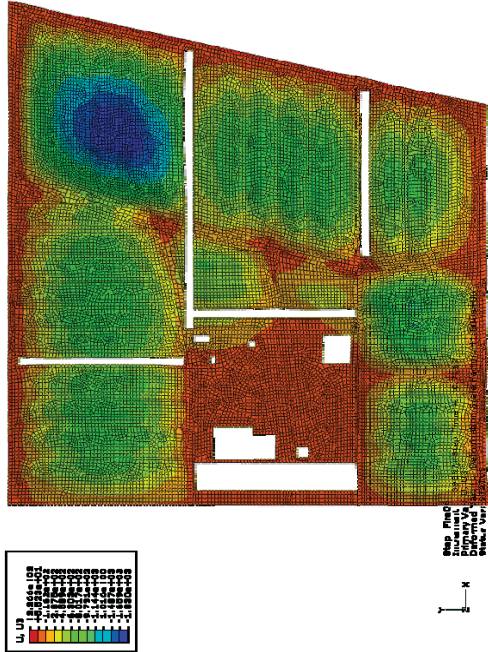
- Figure 60 shows the vertical deflection contours of the slab as the analysis terminates, after failure has been initiated and the runaway failure of the north-east corner is clear from the blue contours dominating the north-east bay.

Figure 60: 800°C Unfilled Flutes Case 3 - Vertical Deflection Contours at Analysis Termination (57 minutes of heating at 800°C)

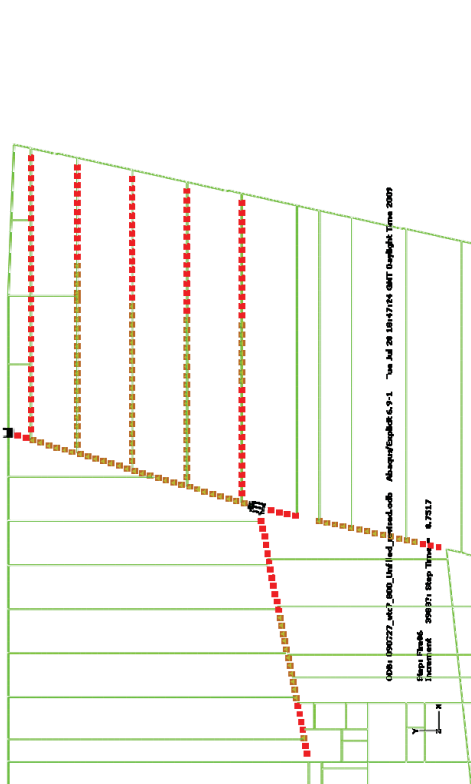
Figure 61: 800°C Unfilled Flutes Case 3 - Shear Stud Breakage 640°C Girder Top Flange Temperature (to be compared to Figure 24)

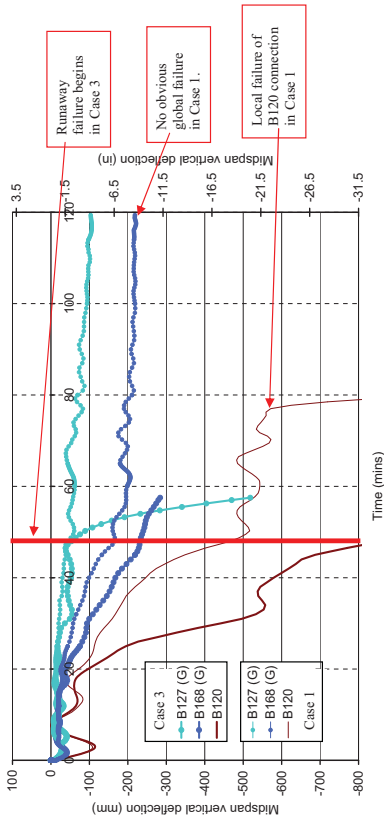
Mid-span deflections between Case 1 and Case 3 are presented against time in Figure 62 and against temperature in Figure 63. It is apparent that the difference of approximately 100°C in peak temperature of the top flange and web is enough to trigger a potential global failure mechanism in Case 3.

Figure 62: Comparison of Mid-span Deflection between Case 1 and Case 3 (Against Time)

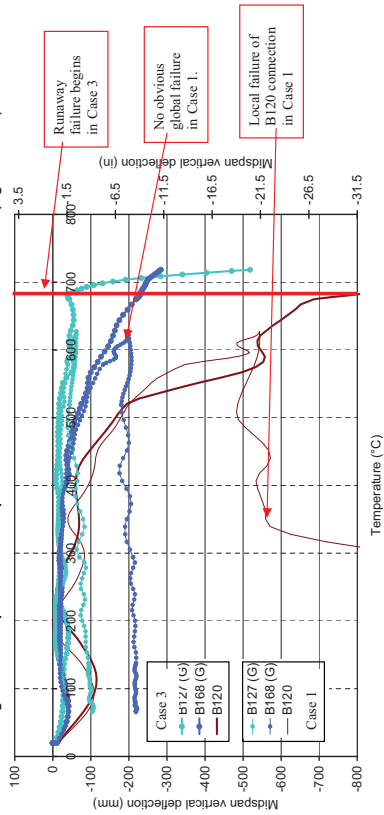
Figure 63: Comparison of Mid-span Deflection between Case 1 and Case 3 (Against Girder 79-44 Top Flange Temperature)

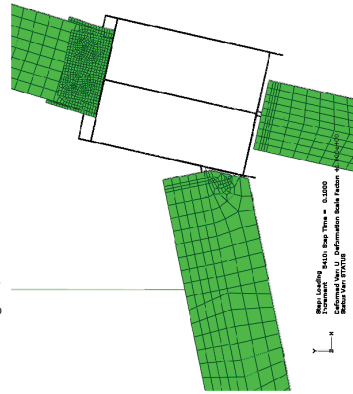
The movement of the 3 connections around Column 79 are imaged in Figure 64, Figure 65 and Figure 66. These images are taken at ambient, halfway through the heating phase and just before the end of heating (failure), respectively.

- Seating bolts break early in the fire due to longitudinal expansion of Girder 79-44. Top clip bolts fail shortly afterward
- End of girder is then free to be moved about on the seating plate
- Toward the middle of the heating phase the girder end is jammed into the corner between the column flange and the extension of the column side plate beyond the flange
- At approximately 47 minutes into the heating phase runaway failure of the north-east corner begins, focussed around the Column 79 seated connection

Figure 64: 800°C Unfilled Flutes Case 3 - Column 79 Seat Connection at Ambient

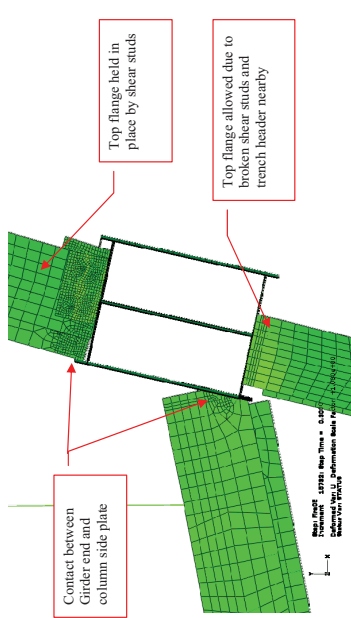
Figure 65: 800°C Unfilled Flutes Case 3 - Column 79 Seat Connection at 30 Mins

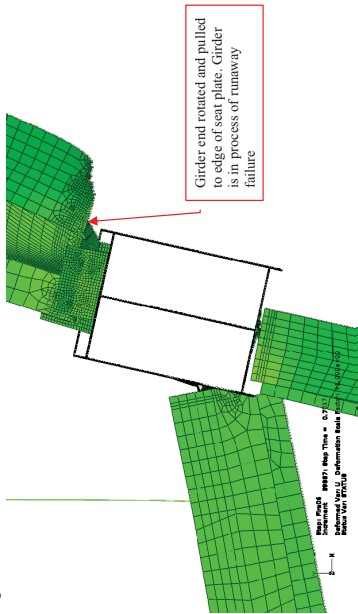
Figure 66: 800°C Unfilled Flutes Case 3 - Column 79 Seat Connection at Analysis Termination

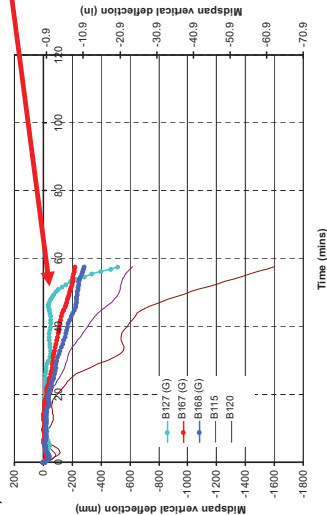
Figure 69: 800°C Unfilled Flutes Case 3 - Selected Beam and Girder Vertical Deflections

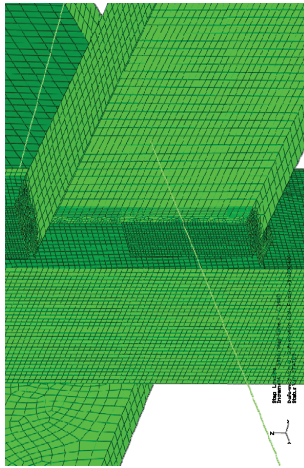
Figure 70: 800°C Unfilled Flutes Case 3 - Column 79 Seat Connection @ Ambient

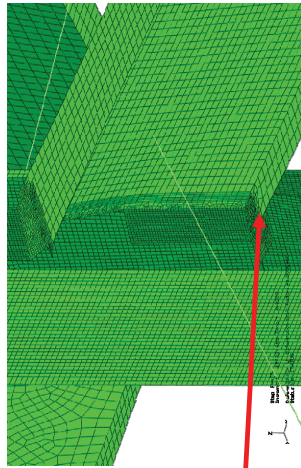
Figure 71: 800°C Unfilled Flutes Case 3 - Column 79 Seat Connection @ 30 Mins

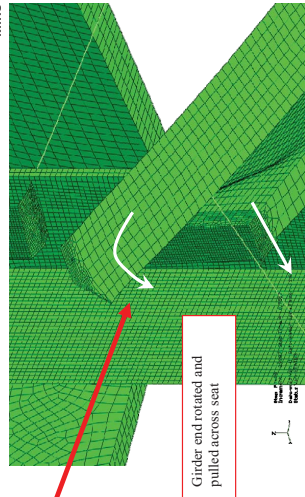
Figure 72: 800°C Unfilled Flutes Case 3 - Column 79 Seat Connection @ Analysis Termination

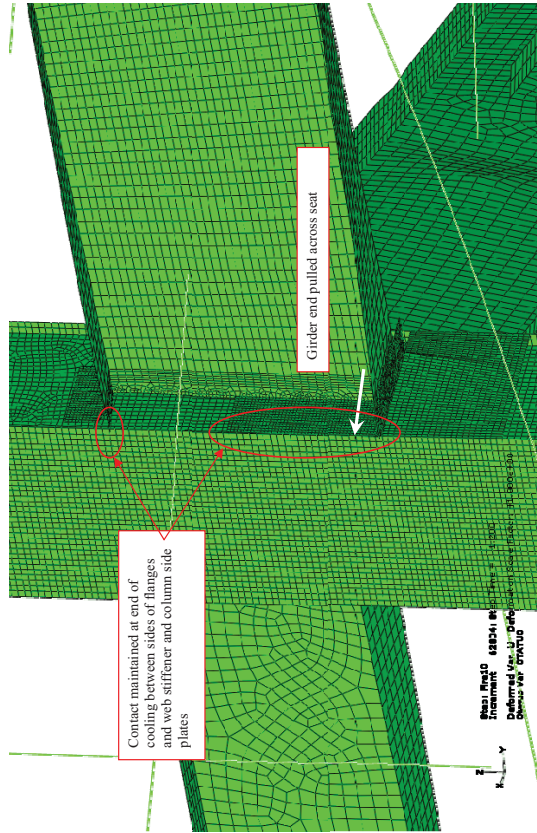
Figure 73: 800°C Filled Flutes Case 4 - Column 79 Seated Connection at End of Cooling
